# Summary report on steels K55, L80 including H<sub>2</sub>S containing atmosphere and a quenched reference material

Dissemination level: PU - Public Hystories deliverable D4.4-0 Date: 12 January 2022

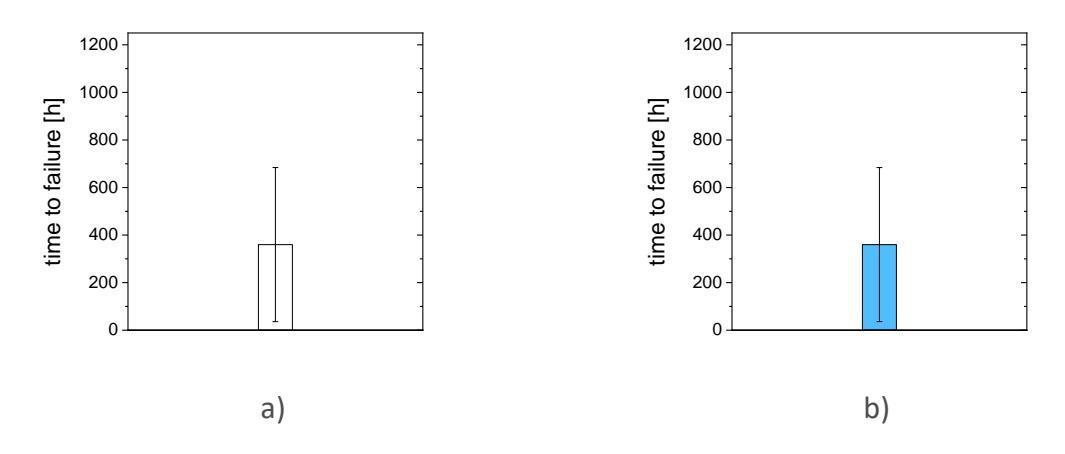
Figure 1: Time to failure of quenched material after testing in a) gas A (120 bar H<sub>2</sub>), no electrolyte, 25 °C, b) gas D (120 bar H<sub>2</sub> + 15 bar CO<sub>2</sub> + 1 bar H<sub>2</sub>S), 200 g/l NaCl, immersion in gas + electrolyte, 120 °C.

So far two tests under very different conditions (Figure 1) have been performed. Both tests resulted in a failure. The time to failure cannot be given since the autoclave are only opened after 720 h.

A fracture occurred in both conditions. This is shown in Figure 1.

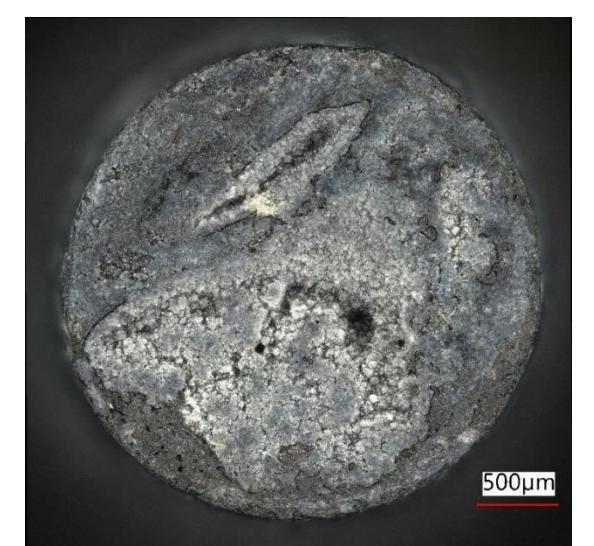
Figure 2: Fracture surface of quenched steel tested in gas D (120 bar H<sub>2</sub> + 15 bar CO<sub>2</sub> + 1 bar H<sub>2</sub>S), 200 g/l NaCl, immersion in gas + electrolyte, 120 °C.

Figure 2 shows a fracture image of a quenched steel. The test condition was the more aggressive one in gas D ( $H_2 + CO_2 + H_2S$ ) with an electrolyte of 200 g/l sodium chloride NaCl at 120°C. Under these severe conditions a fracture occurred. It did not make sense to make a SEM examination with this fracture surface, because the surface is covered by a thick layer of

corrosion products. The hydrogen content in the specimen was 0.86 ppm after the experiment.

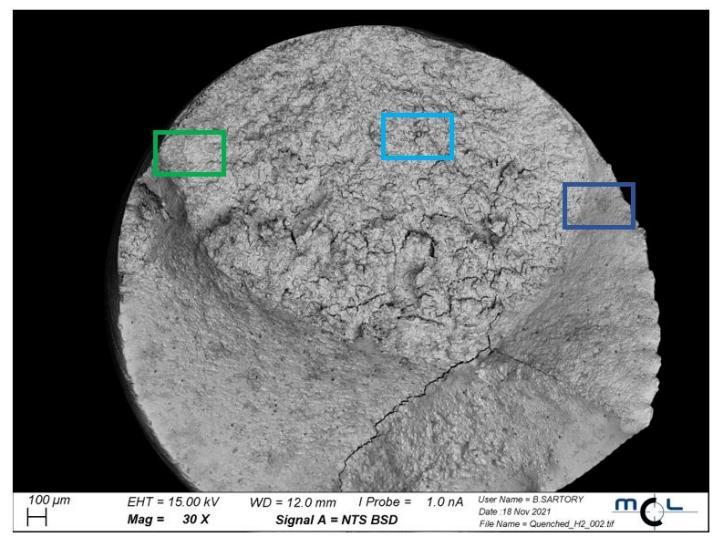
Figure 3: Fracture surface of quenched steel tested in gas A (120 bar H<sub>2</sub>), no electrolyte, 25 °C, 30x.

Figure 3 shows a fracture image of the quenched steel tested under more mild conditions. The test condition was dry gas A ( $H_2$ ) at room temperature. Under these conditions also a fracture occurred. On the upper site of the fracture the starting point of the fracture can be observed. A hydrogen amount of only 0.10 ppm was measured using the TDS.

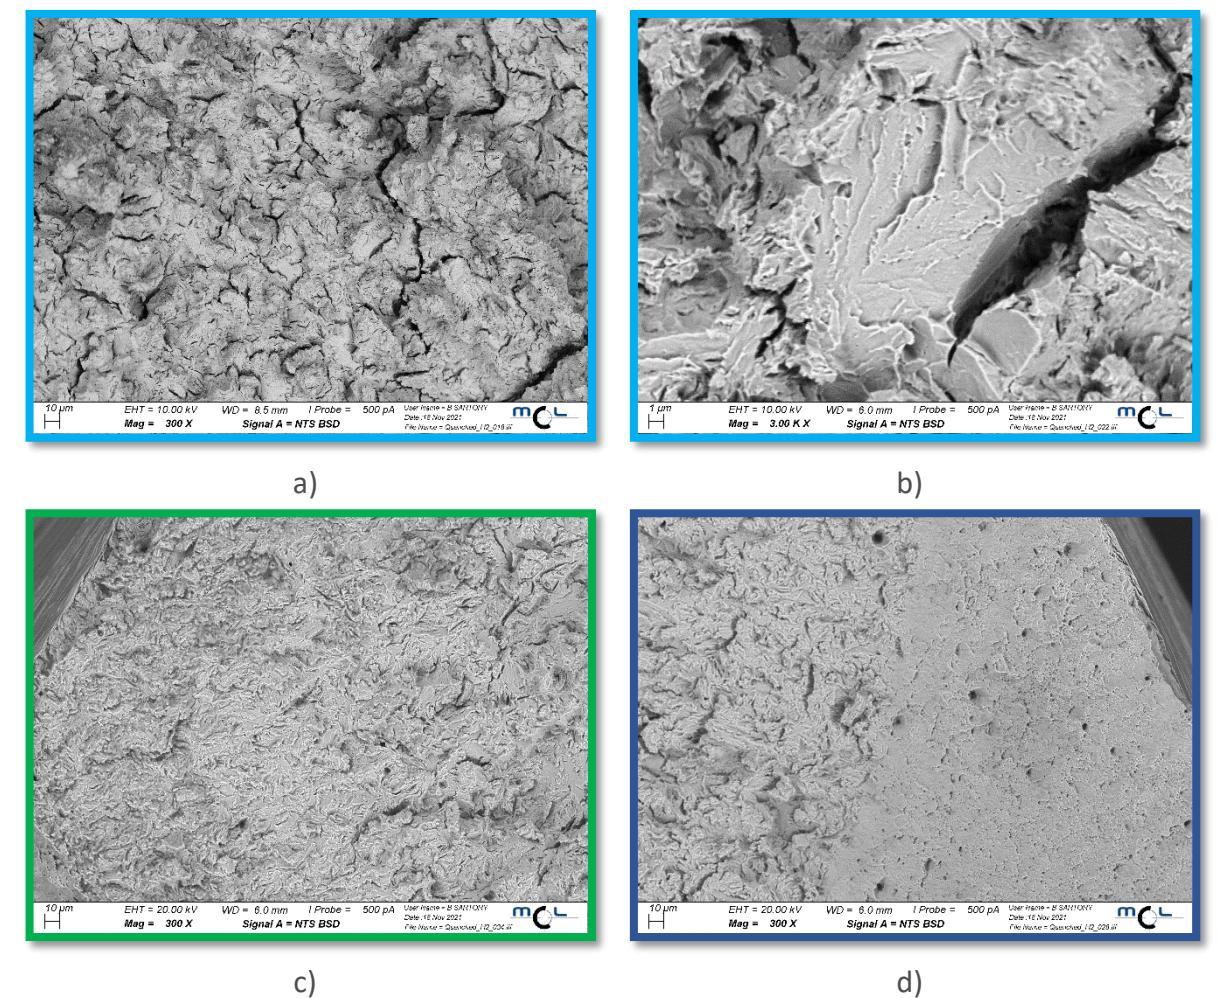
Figure 4: Details of fracture surface of quenched steel a) hydrogen fracture 300x, b) river patterns at hydrogen fracture 3000x, c) hydrogen fracture 300x d) transition zone between hydrogen fracture (left) and ductile forced fracture (right), 300x.

Figure 4 shows the different fracture zones in detail of the quenched material in a SEM. The fractured surface of a hydrogen crack can be separated into several parts. In Figure 4 a), in the light blue frame from Figure 4, a clear hydrogen fracture can be observed. It is an area, in which a ductile and brittle area are present side to side. Figure 4 b) the same fracture area in

the light blue frame is shown with a higher magnification. There is a cleavage like fracture with river patterns and some fine pores typical for a hydrogen induced fracture. In Figure 4 c) the green area shows a brittle fracture as well. In the dark blue area from Figure 3 and magnified in Figure 4 d), the transition area between brittle hydrogen crack and ductile forced fracture is visible.

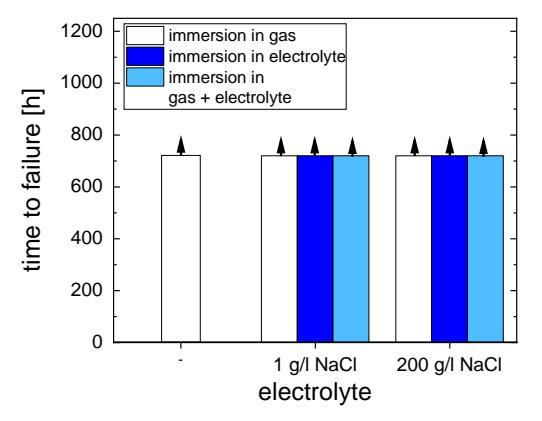
Figure 5: Time to failure of ferritic perlitic steel K55 in gas D: 120 bar  $H_2$  + 15 bar  $CO_2$  + 1 bar  $H_2S$ .

Figure 5 shows the time to failure of ferritic perlitic steel K55 for all gas compositions. Gases without  $H_2S$  (non-sour gas) are gas A (120 bar  $H_2$ ) and gas B (120 bar  $H_2 + 15$  bar  $CO_2$ ). Gases with  $H_2S$  (sour gas) are gas C (120 bar  $H_2 + 1$  bar  $H_2S$ ) and gas D (120 bar  $H_2 + 15$  bar  $CO_2 + 1$  bar  $H_2S$ ). No fracture at all occurred under any condition. The Figure 5 below shows as an example time to failure in gas D. No cracks at all occurred for steel K55. The same happened for gases A, B and C.

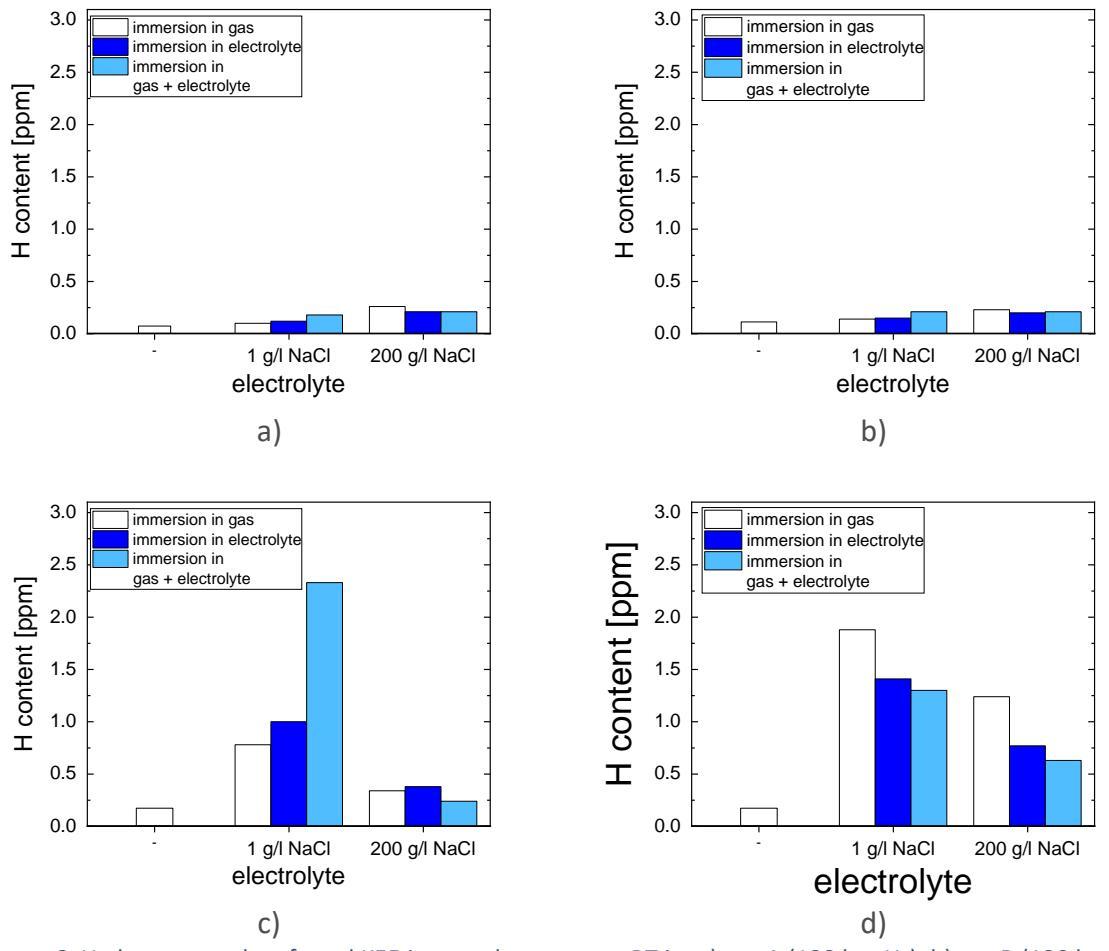
Figure 6: Hydrogen uptake of steel K55 in autoclave tests at RT in, a) gas A (120 bar  $H_2$ ), b) gas B (120 bar  $H_2$  + 15 bar  $CO_2$ ), c) gas C (120 bar  $H_2$  + 1 bar  $H_2$ S) and d) gas D (120 bar  $H_2$  + 15 bar  $CO_2$  + 1 bar  $H_2$ S).

Figure 6 shows the hydrogen uptake of steel K55 in four test gases A to D at room temperature (25  $^{\circ}$ C).

In this autoclave tests with steel K55 at room temperature (20°C), the lowest hydrogen value is 0.07 ppm for gas A (see Figure 6 a)) and the highest value is 2.33 ppm for gas C (see Figure 6 c)). The hydrogen content was measured by thermal desorption spectroscopy (TDS).

Gases A and B show no increased hydrogen uptake. Gases C and D with  $H_2S$  show increased values whenever an electrolyte is present. If no electrolyte is present, the presence of  $H_2S$  has almost no effect on hydrogen uptake. In gases C and D higher hydrogen contents were generated with the presence of an electrolyte. However, no failure occurred.

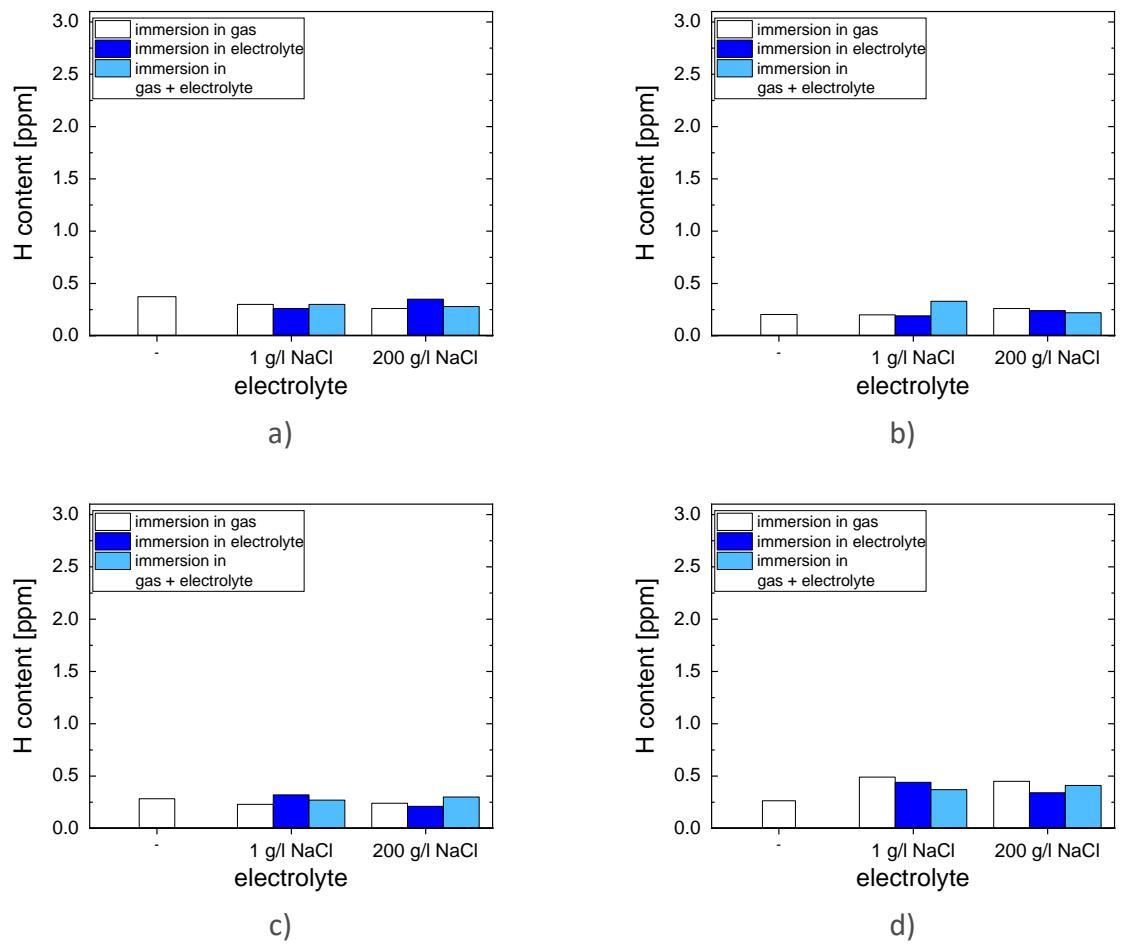
Figure 7: Hydrogen uptake of steel K55 in autoclave tests at 120 °C in, a) gas A (120 bar  $H_2$ ), b) gas B (120 bar  $H_2$  + 15 bar  $CO_2$ ), c) gas C (120 bar  $H_2$  + 1 bar  $H_2S$ ) and d) gas D (120 bar  $H_2$  + 15 bar  $CO_2$  + 1 bar  $H_2S$ ).

Figure 7 illustrates the hydrogen uptake of steel K55 in all conditions at 120 °C. In the autoclave tests with the steel K55 at 120 °C, the lowest value is 0.19 ppm in gas B (see Figure 7 b)) and the highest value is 0.49 ppm in gas D (see Figure 7 d)). The amount of hydrogen was also measured by TDS.

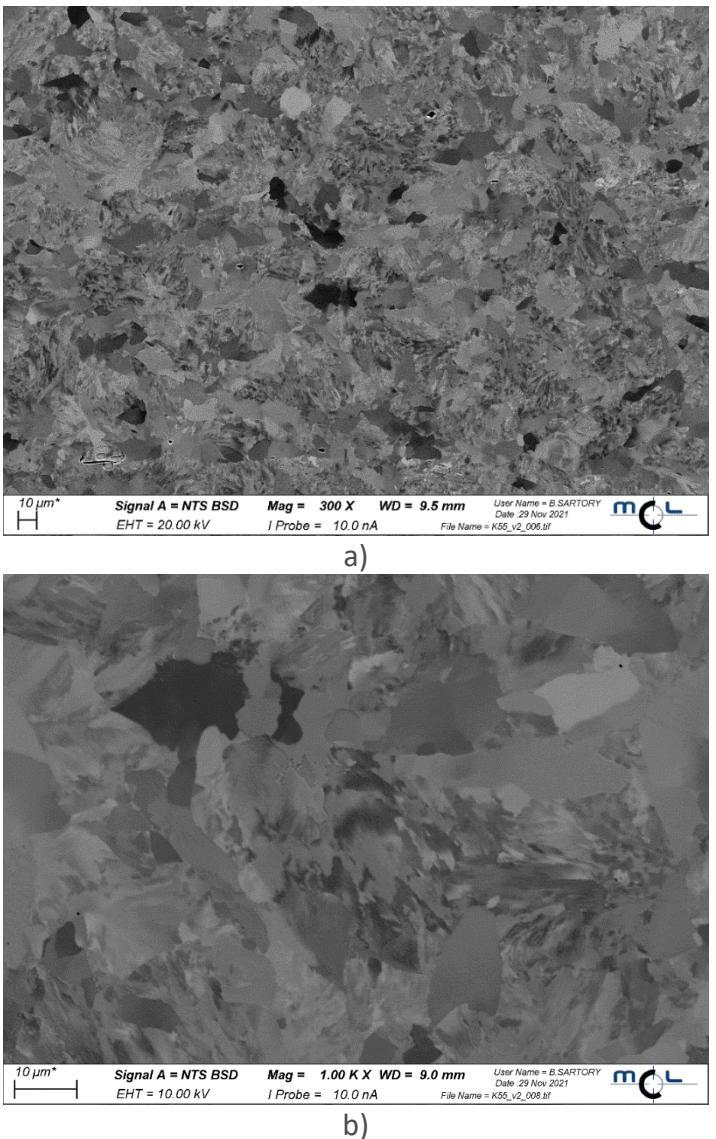
Figure 8: Microstructure of steel K55 a) 300x b) 1000x.

Figure 8 a) shows a microstructure image of ferritic and perlitic steel K55 in the SEM at a magnification of 300. Figure 8 b) also shows the microstructure of the steel K55 but at a higher magnification of 1000.

In Figure 8, the pearlite grains are shown having different shades of grey, while the ferrite grains have a uniform, white or gray color.

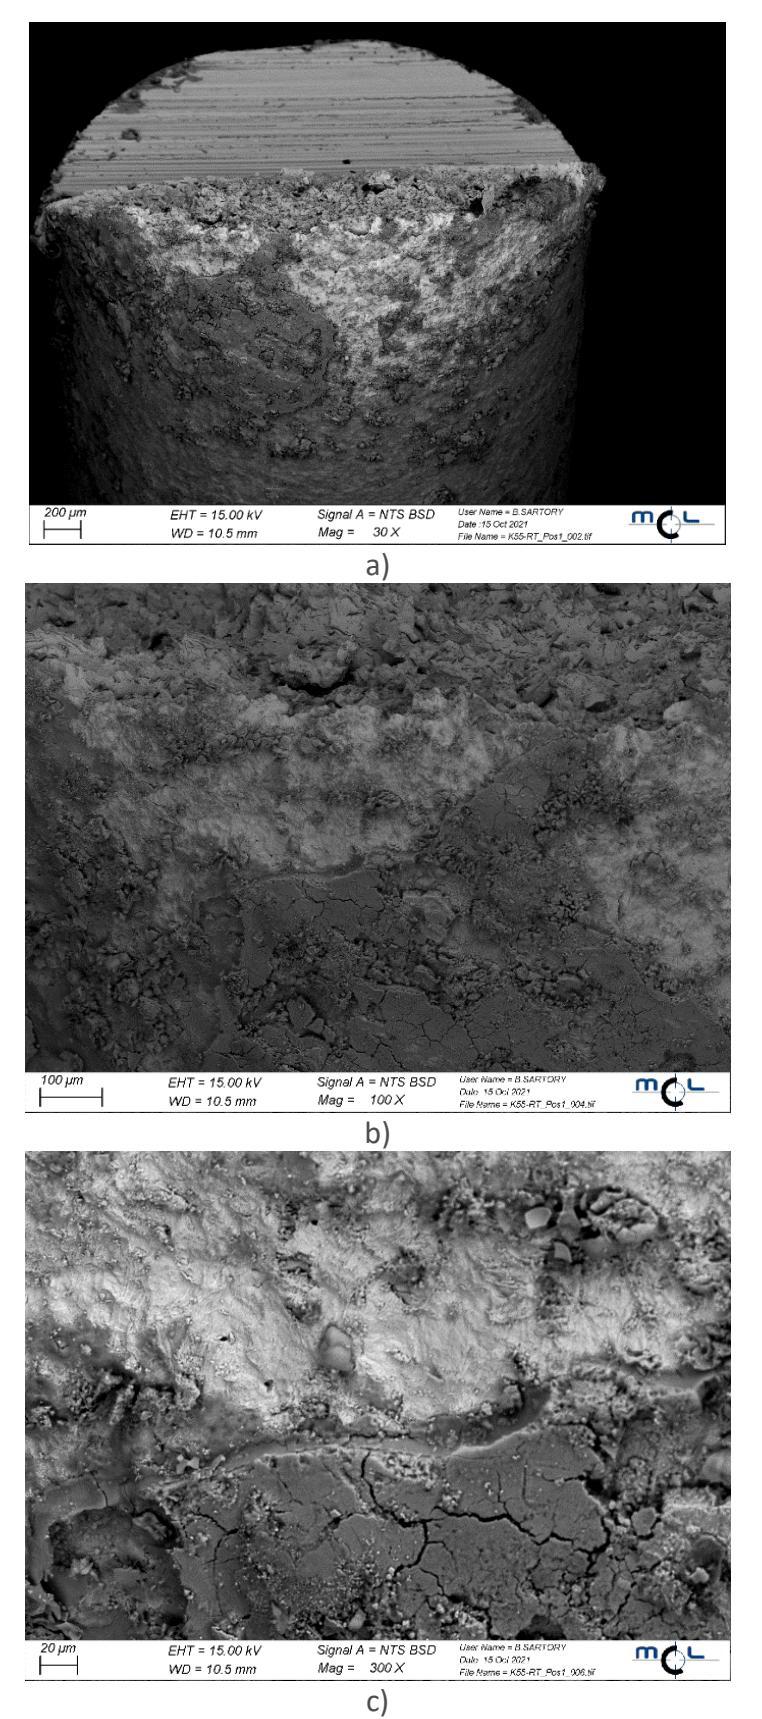
Figure 9: Surface of steel K55 after exposure to gas C, immersed in gas and electrolyte (1g/l NaCl) at room temperature, a) 30x, b) 100x and c) 300x.

Specimens with layers have been cut partially and the residual ligament was broken after cooling in liquid nitrogen to obtain a brittle fracture and to characterize the surface layers. Figure 9 a) shows a layer of steel K55 in a SEM at a magnification of 30x. Figure 9 b) also shows the layer on steel K55 but at a larger magnification (100x) and Figure 9 c) is a magnification of 300x. Specimen was tested in gas C with 1 g/l NaCl immersed in gas and electrolyte at 25 °C. There is no uniform layer but a porous and not dense one with many flakes and microcracks.

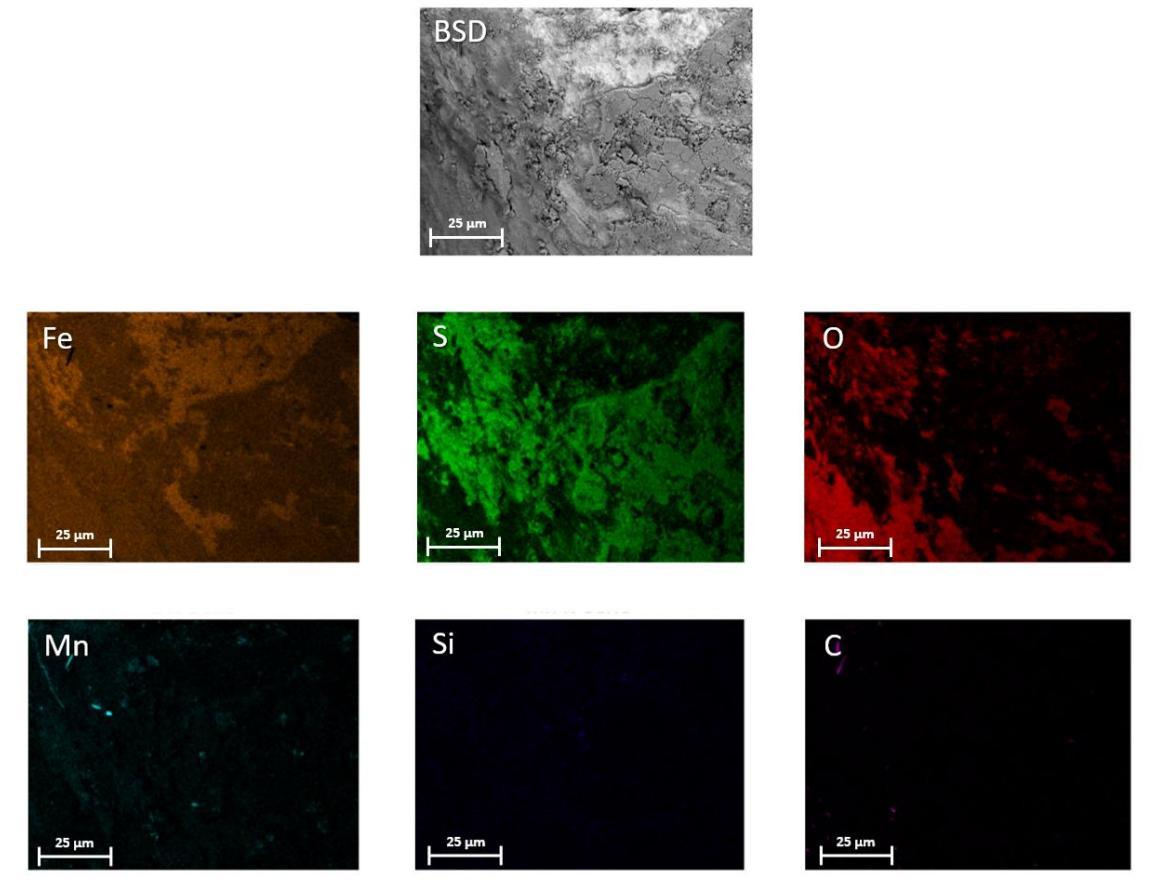
Figure 10: Element mappings of the surface of steel K55 tested in gas C, 1 g/l NaCl, immersed in gas and electrolyte, room temperature.

In Figure 10 element mappings of the surface of the same specimen are shown to characterize the chemical composition of the layer. There is a mixed oxide-sulfide layer on the surface and a clear distinction (separation), whether the oxide or sulfide is the top layer cannot be given. Therefore, a cross section was prepared, shown in Figure 11.

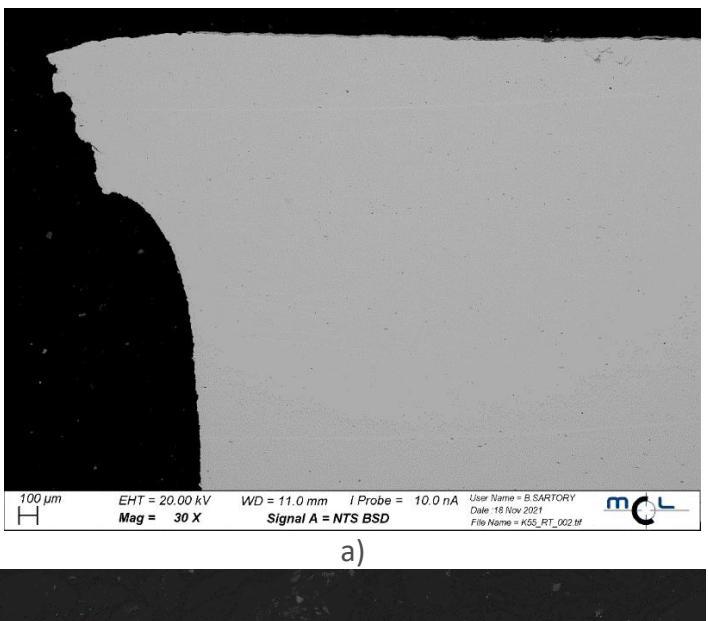
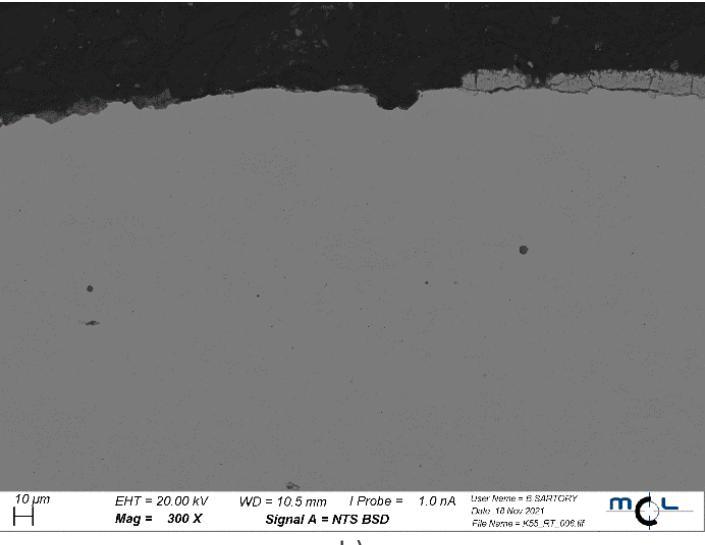
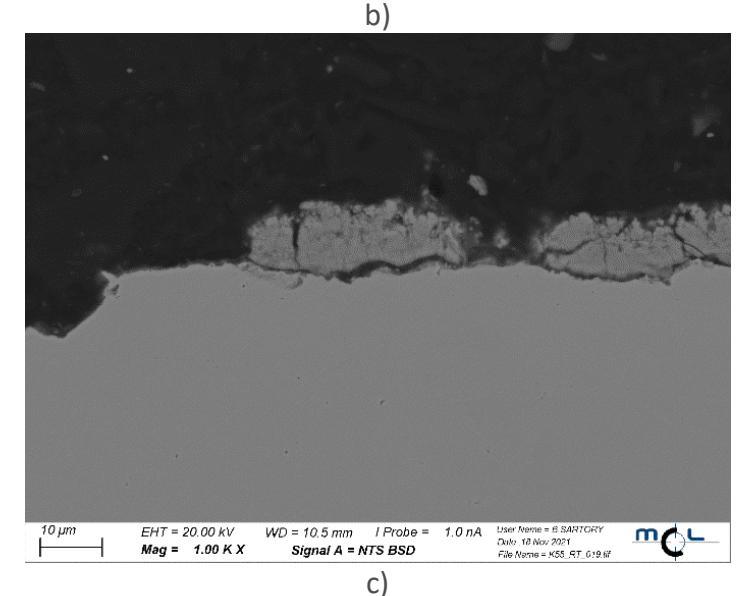
Figure 11: SEM images of cross section of steel K55 tested in gas C with 1g/l NaCl (immersed in gas and electrolyte) at room temperature, a) 30x, b) 300x and c) 1000x.

In Figure 11 a metallographic section for better characterization of the layer is shown. The SEM images were taken at magnification 30x, 300x and 1000x. In the higher magnification images, it is clear that the layer is not uniform. It can also be seen, that the layer is porous and not dense and tends to spall off.

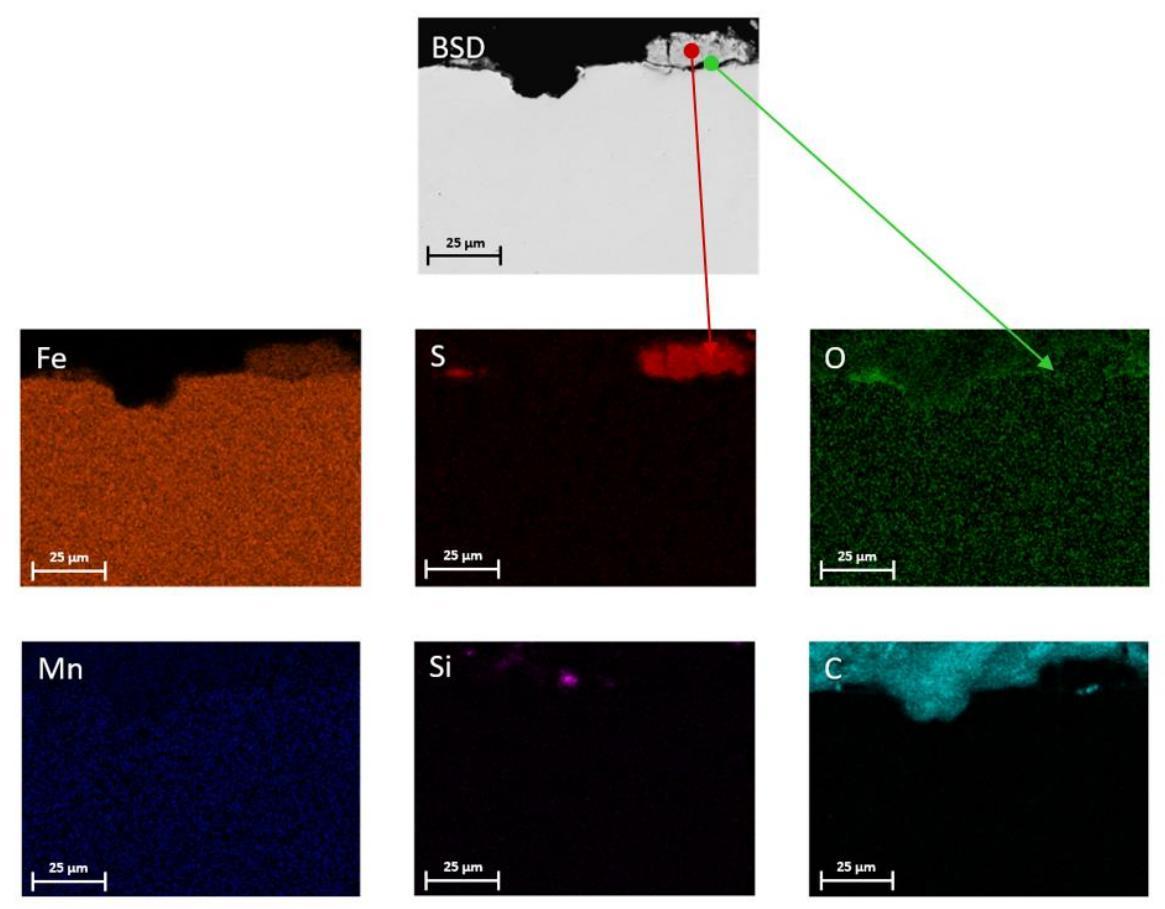
Figure 12: Element mappings of layer on steel K55 tested in gas C, 1 g/l NaCl, immersed in gas and electrolyte, room temperature.

Element mappings of the layer are presented in Figure 12. The layer consists of two parts, an inner iron oxide and an outer sulfide layer. These two layers are not distributed uniformly on the surface. There is a high degree of spelling off.

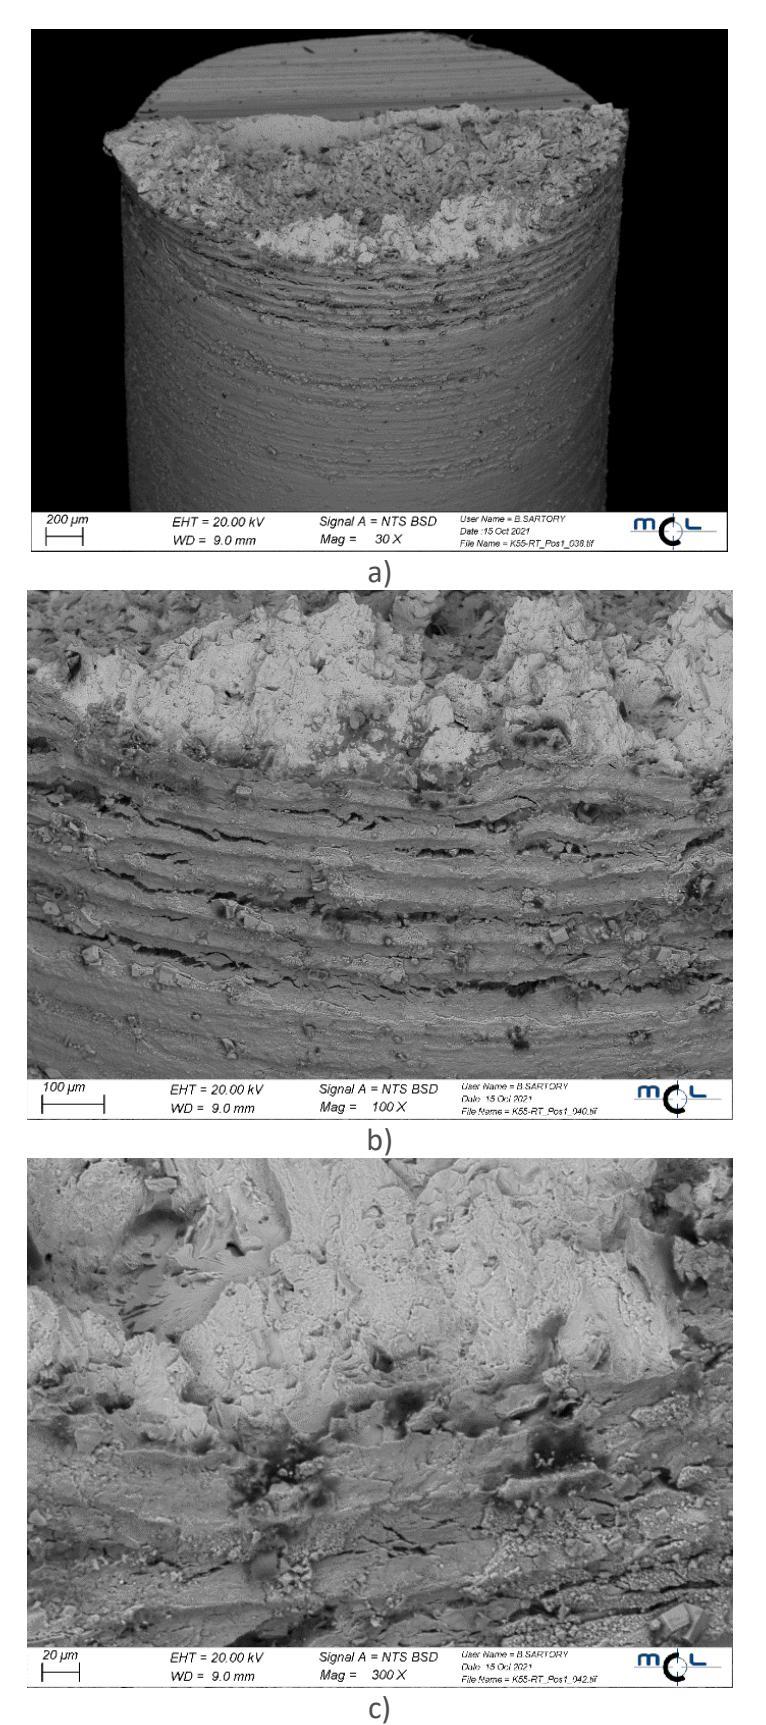
Figure 13: Surface of steel K55 after exposure to gas C, immersed in gas and electrolyte (1g/l NaCl) at 120 °C, a) 30x, b) 100x and c) 300x.

In Figure 13 SEM images of steel K55 tested in gas C, 1g/l NaCl, immersed in gas and electrolyte, 120 °C, are shown in three magnifications. There is a uniform layer of corrosion products.

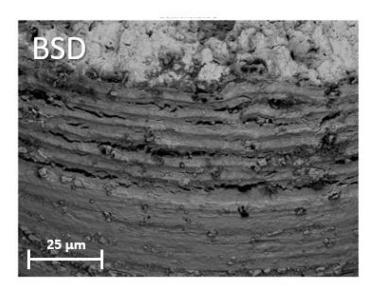
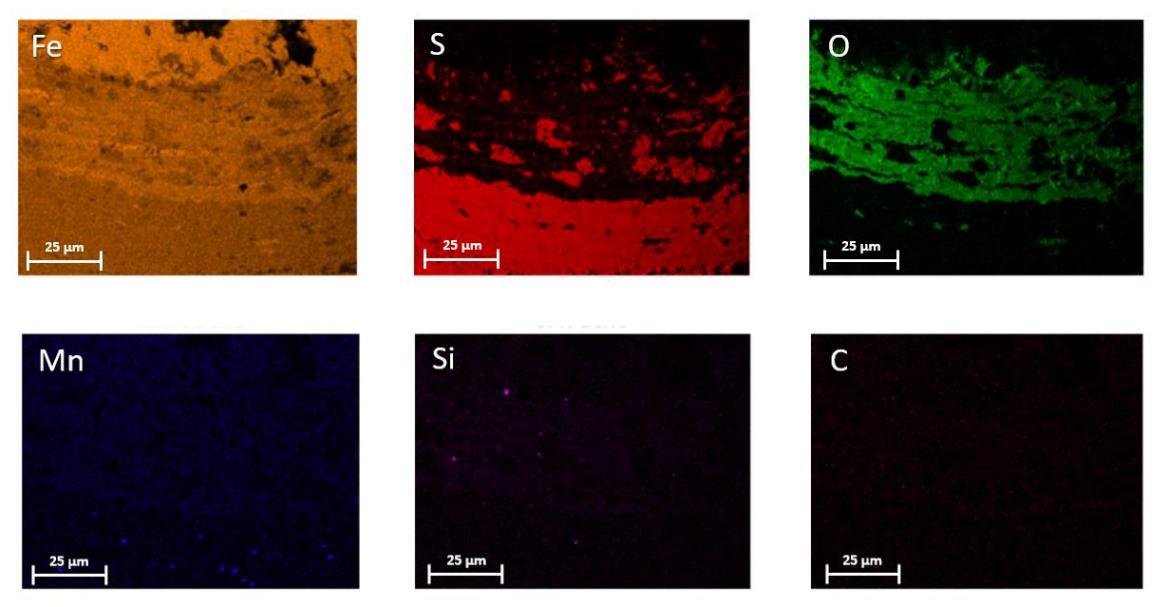
Figure 14: Element mappings of the surface of steel K55 tested in gas C, 1 g/l NaCl, immersed in gas and electrolyte, 120 °C.

In Figure 14 element mappings are shown to characterize chemical composition of the layer. In the individual element evaluations, it can be seen that there are two different layers. The oxide layer is the inner layer and the outer layer is the sulfide layer. The iron sulfide layer is more densely packed and this inhibits more the hydrogen uptake. For determination of layer thickness a metallographic cross section was prepared, shown in Figure 15.

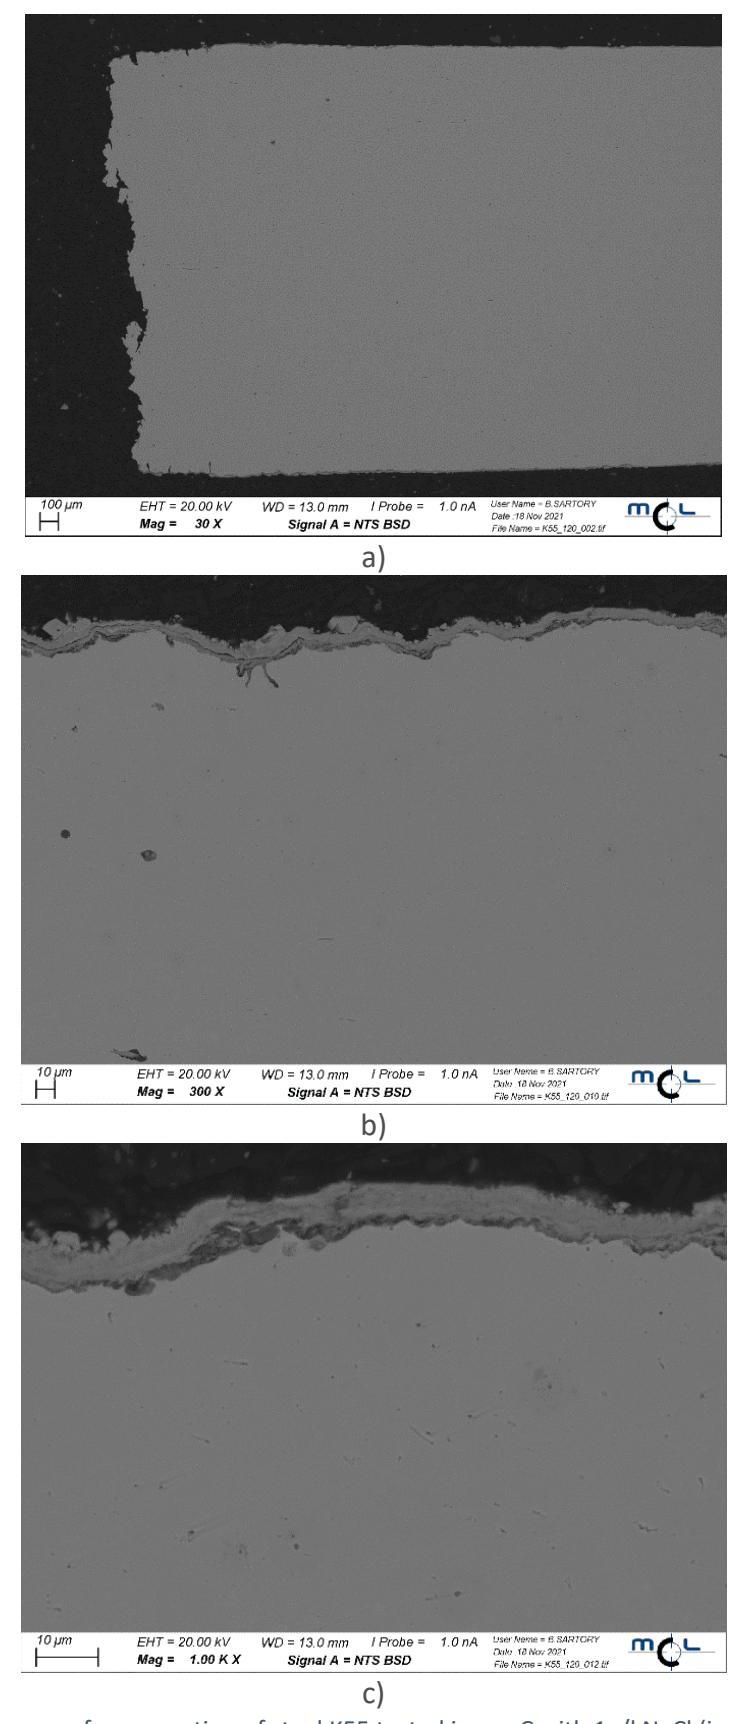
Figure 15: SEM images of cross section of steel K55 tested in gas C with 1g/l NaCl (immersed in gas and electrolyte) at 120 °C, a) 30x, b) 300x and c) 1000x.

The SEM images of the section show that the layer is uniform (Figure 15). It is also observed, that the layer is more uniformly distributed on the surface, compared to tests at room temperature. This says for a better barrier to hydrogen absorption at higher temperatures, so that the absorbed hydrogen content is lower at 120 °C when compared to room temperature.

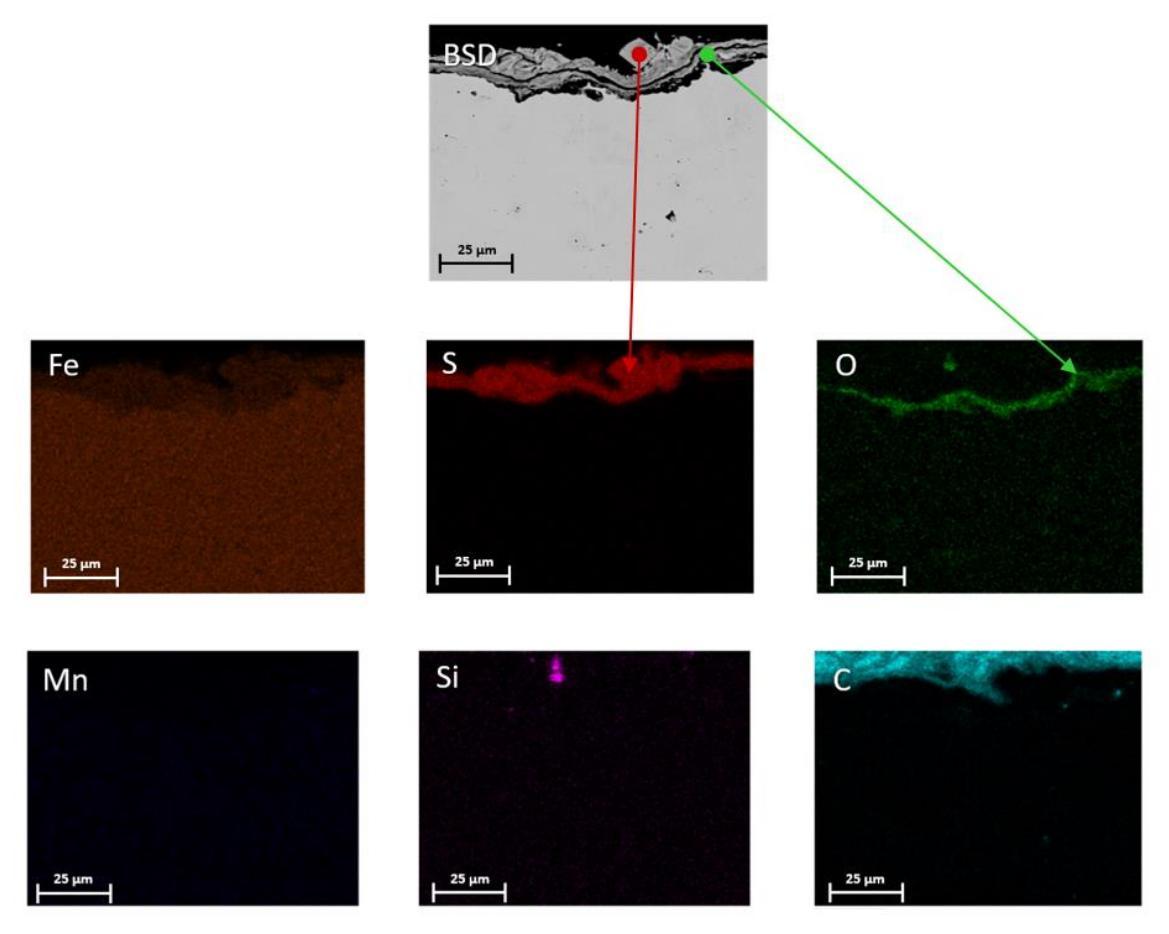
Figure 16: Element mappings of layer on steel K55 tested in gas C, 1 g/l NaCl, immersed in gas and electrolyte, 120 °C.

Figure 16 shows the chemical analysis of the layers in element mappings. Two layers are clearly visible, an oxidic and a sulfidic one. Both layers are clearly separated from each other and obviously more dense when compared to the layers obtained at room temperature.

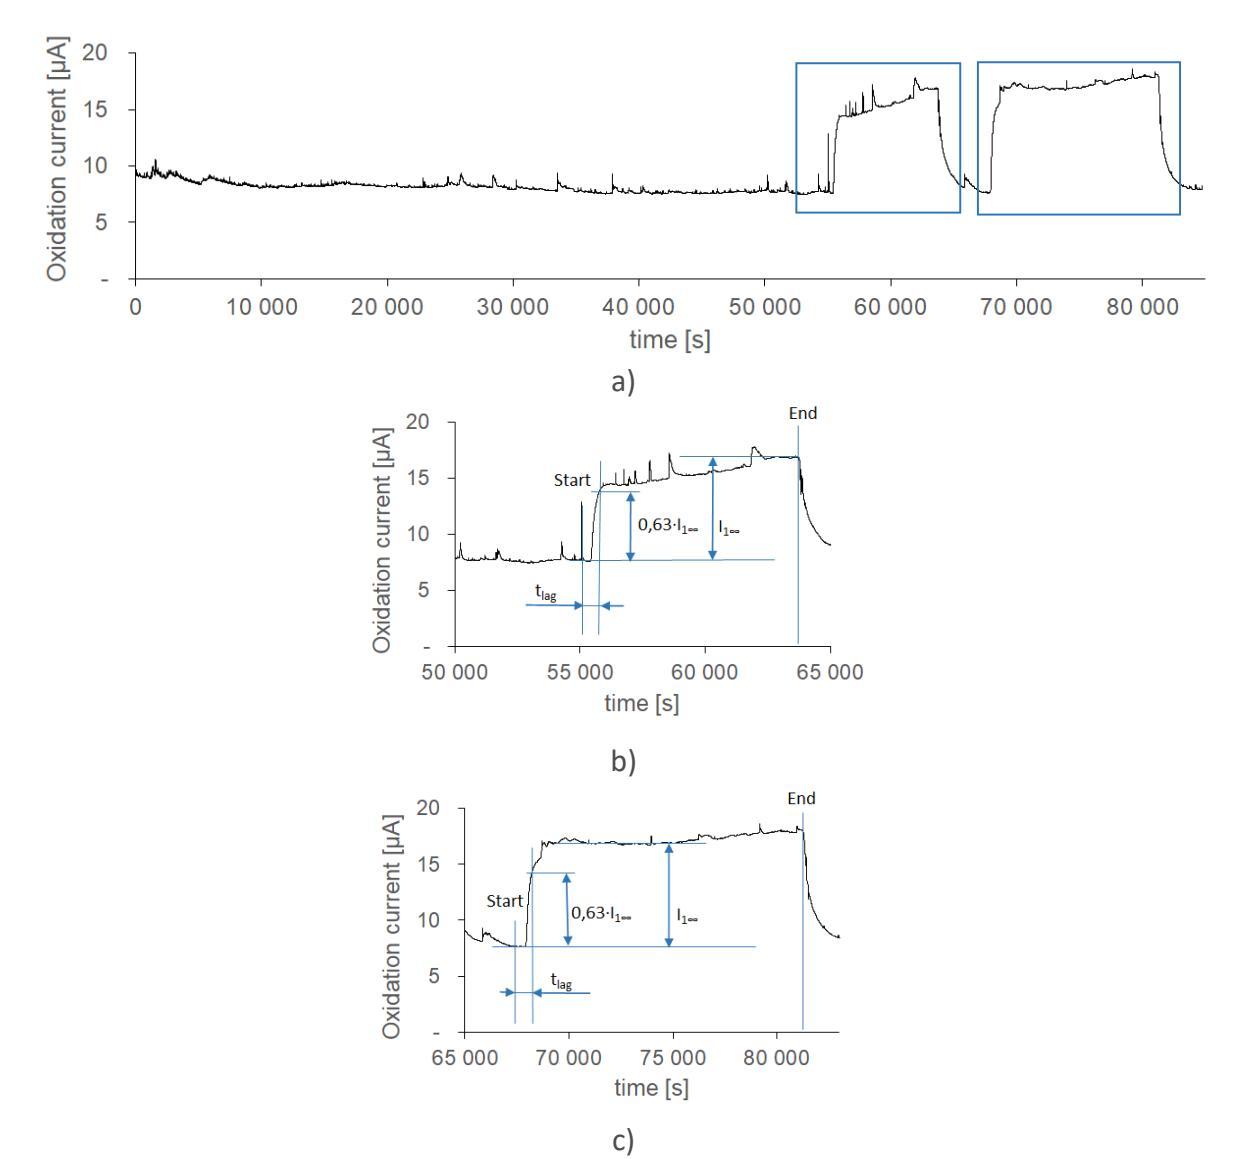
Figure 17: a) Results from hydrogen permeation tests on steel Permeation current as function of time for 2 consecutive loadings, b) detail permeation current as function of time for 1<sup>st</sup> loading with evaluation, c) detail permeation current as function of time for 2<sup>nd</sup> loading with evaluation.

The oxidation current was measured over the time to determine the effective diffusion coefficient. Results from hydrogen permeation tests on steel K55 can be seen in Figure 17. In Figure 17 a) the permeation current as function of time for 2 consecutive loadings can be seen, in Figure 17 b) a detail of the permeation current as function of time for first loading with evaluation is shown, in Figure 17 c) a detail of the permeation current as function current as function of time for the second loading with evaluation is given.

The first loading has an effective diffusion coefficient  $D_{eff}$  of  $6.22 \cdot 10^{-6} \frac{cm^2}{s}$ , seen in Table 1 and the second loading has an  $D_{eff}$  value of  $7.96 \cdot 10^{-6} \frac{cm^2}{s}$ , see Table 2. There is a small amount of deep traps and the second loading is slightly faster than the first one. The literature confirms, that the value is within the range for carbon steels. The results show diffusion coefficients for non-sour gas resistant steels as expected from the literature review as well.

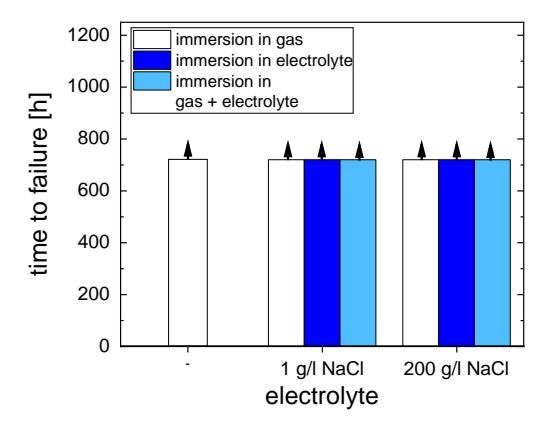
```
Figure 18: Time to failure of a tempered martensitic steel L80 in gas D: 120 bar H_2 + 15 bar CO_2 + 1 bar H_2S.
```

Figure 18 shows the time to failure of tempered martensite steel L80 for all gas compositions. No fracture occurred under any condition. The Figure 18 below shows as an example time to failure in gas D. No cracks at all occurred for the steel L80. The same happened for gases A, B and C.

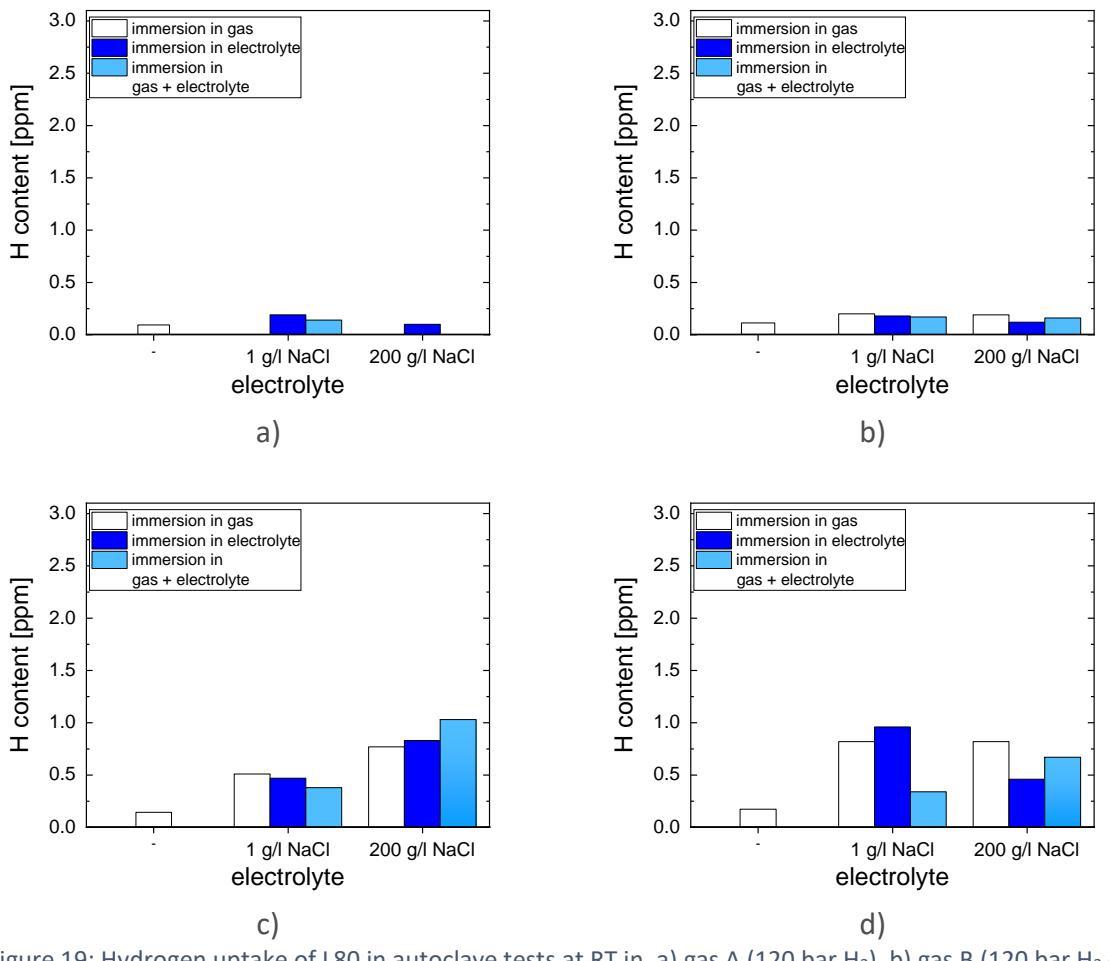
Figure 19: Hydrogen uptake of L80 in autoclave tests at RT in, a) gas A (120 bar  $H_2$ ), b) gas B (120 bar  $H_2 + 15$  bar  $CO_2$ ), c) gas C (120 bar  $H_2 + 1$  bar  $H_2S$ ) and d) gas D (120 bar  $H_2 + 15$  bar  $CO_2 + 1$  bar  $H_2S$ ).

Figure 19 illustrates the hydrogen uptake at 25 °C in a) gas A and b) gas B, both gases do not contain hydrogen sulfide H<sub>2</sub>S. Figure 19 c) shows the uptake in gas C and Figure 19 d) shows the hydrogen content after exposure to gas D. In the autoclave tests with the steel L80 at room temperature, the lowest value is 0.09 ppm for gas A (see Figure 19 a)) and the highest value is 1.03 ppm for gas C (see Figure 19 c)), the amount of hydrogen was measured using TDS. There is a certain hydrogen uptake in gases C and D when an electrolyte is present. This is due to the lowering of the solution pH by H<sub>2</sub>S.

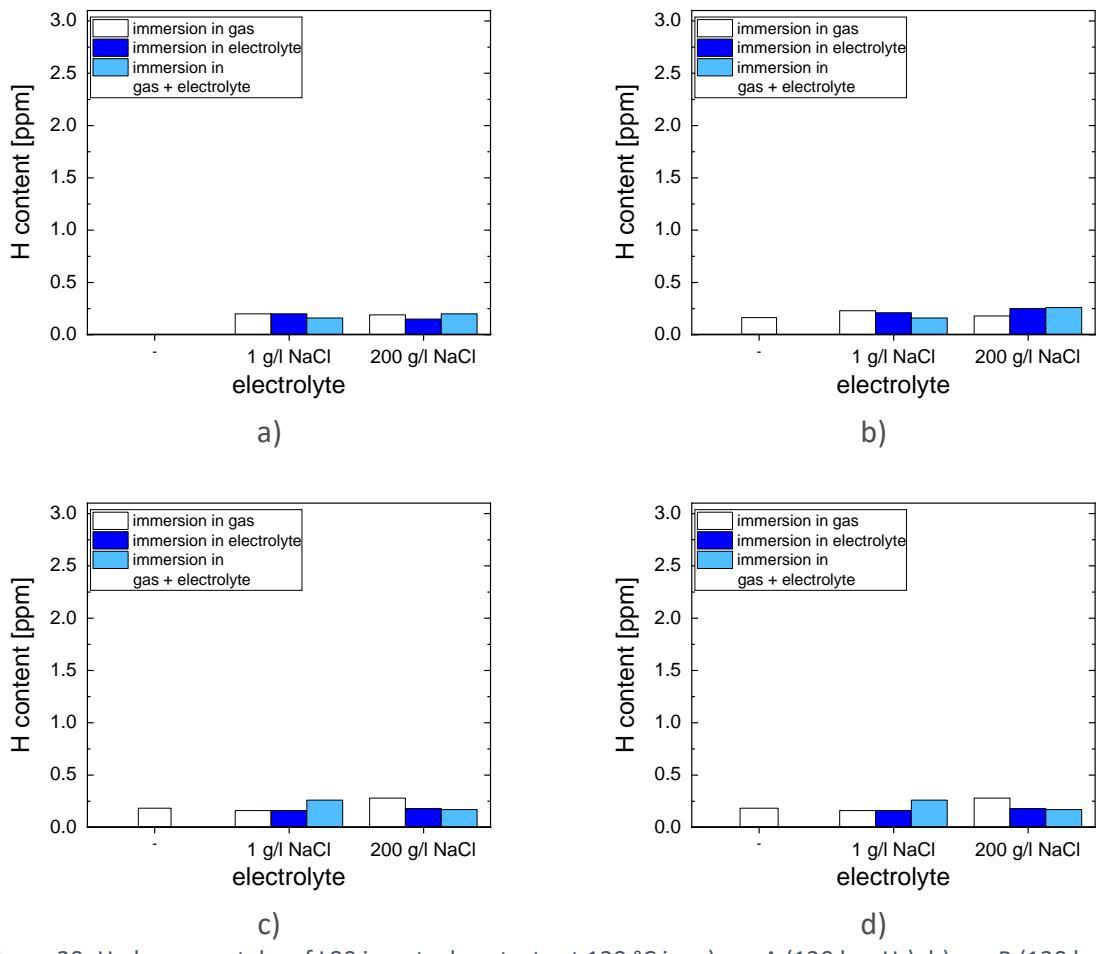
Figure 20: Hydrogen uptake of L80 in autoclave tests at 120 °C in, a) gas A (120 bar H<sub>2</sub>), b) gas B (120 bar H<sub>2</sub> + 15 bar CO<sub>2</sub>), c) gas C (120 bar H<sub>2</sub> + 1 bar H<sub>2</sub>S) and d) gas D (120 bar H<sub>2</sub> + 15 bar CO<sub>2</sub> + 1 bar H<sub>2</sub>S).

Figure 20 shows the results after testing L80 in all conditions at 120 °C. In the autoclave tests with the steel L80 at 120 °C, the lowest value is 0.15 ppm for gas A (see Figure 20 a)) and the highest value is 0.32 ppm for gas D (see Figure 20 d)). There is almost no hydrogen uptake in the autoclaves. Even H<sub>2</sub>S containing conditions results in low H concentrations in the steel compared to tests at room temperature.

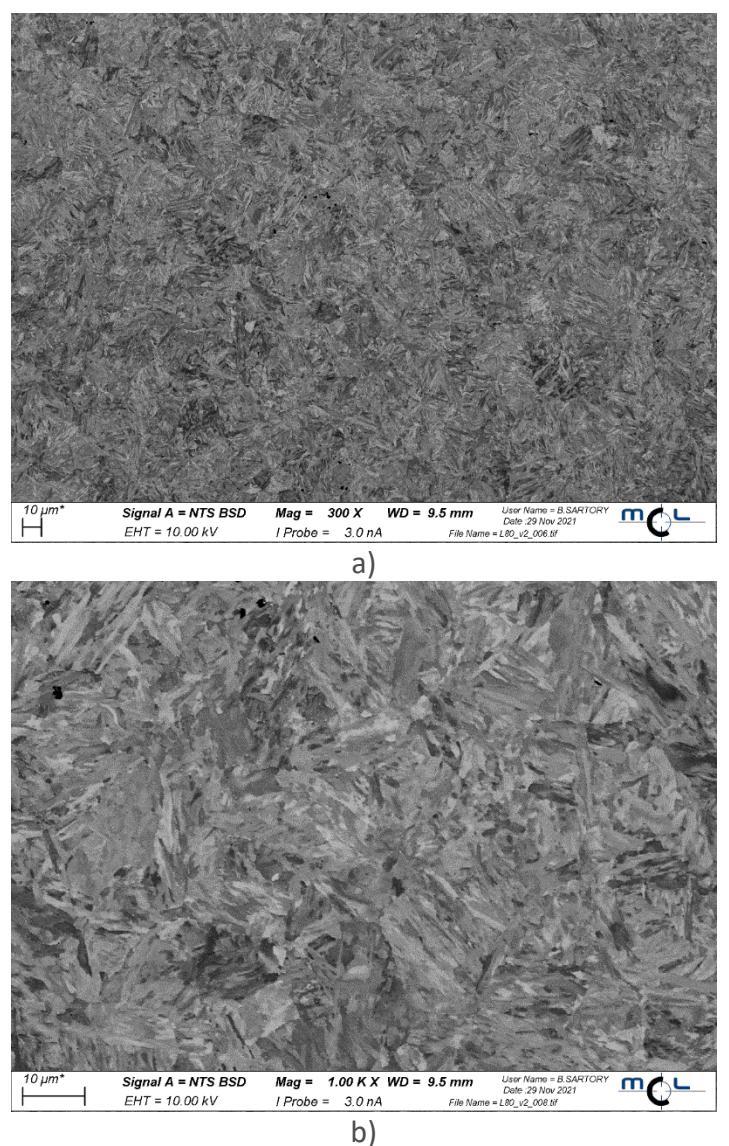
Figure 21: Microstructure of steel L80, a) 300x, b) 1000x.

Figure 21 shows the microstructure of tempered martensite steel L80 at a 300x and 1000x magnification. The grain size is between 20 and 40  $\mu$ m, which is fine. There are only very little non-metallic inclusions.
