# Summary report on steels K55, L80 including H<sub>2</sub>S containing atmosphere and a quenched reference material

Dissemination level: PU - Public Hystories deliverable D4.4-0 Date: 12 January 2022

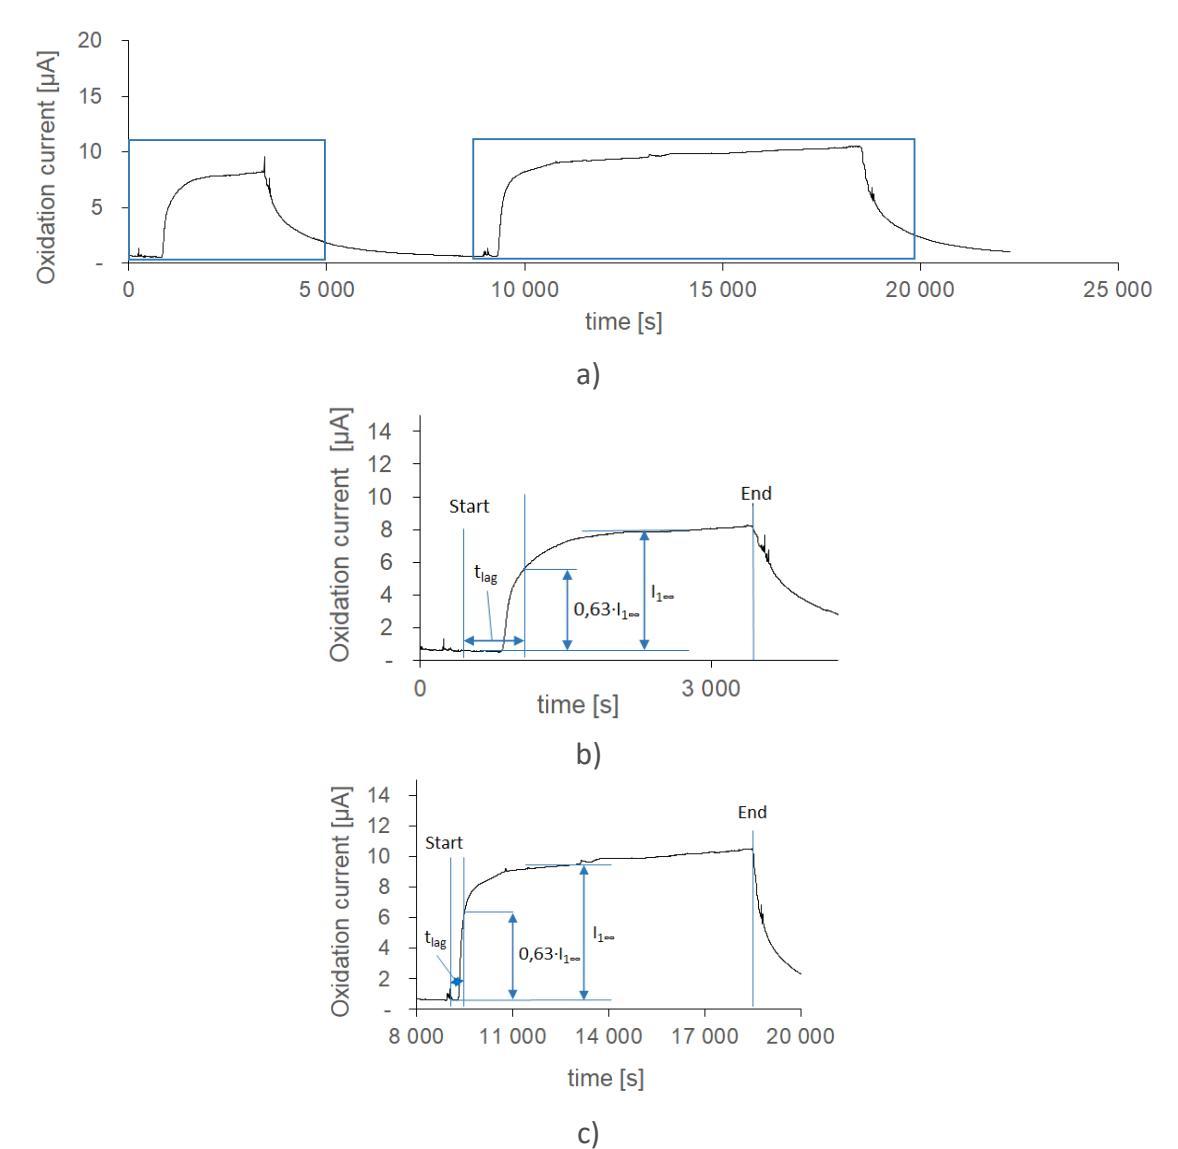
Figure 22: a) Results from hydrogen permeation tests on steel L80 a) Permeation current as function of time for 2 consecutive loadings, b) detail permeation current as function of time for 1<sup>st</sup> loading with evaluation, c) detail permeation current as function of time for 2<sup>nd</sup> loading with evaluation.

The oxidation current was measured as function of time to determine the effective diffusion coefficient. Results from hydrogen permeation tests on the tempered martensite steel L80 can be seen in Figure 22. In Figure 22 a) the permeation current as function of time for two consecutive loadings can be seen, in Figure 22 b) a detail of the permeation current as function of time for the first loading including the evaluation is shown, in Figure 22 c) a detail of the permeation current as function is presented.

The first loading has an effective diffusion coefficient  $D_{eff}$  of  $2.68 \cdot 10^{-6} \frac{cm^2}{s}$  and the second loading  $D_{eff}$  has a value of  $3.98 \cdot 10^{-6} \frac{cm^2}{s}$  (Table 4). These values are comparable to those found in the literature. The steel L80 has more traps, as this steel is also more deformed than the ferritic-pearlitic steel. Consequently the diffusion coefficients are lower.
