# Summary report on all investigated steels

Dissemination level: PU - Public Hystories deliverable D4.6-0 Date: 16 March 2023

Bernd LODER

Montanuniversitaet Leoben, Austria

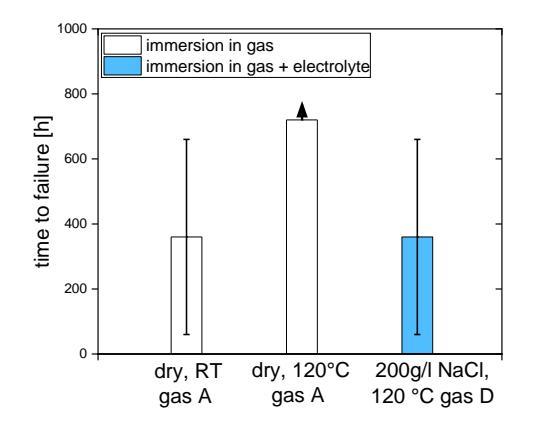
Three tests were performed according to the graph (Figure 1). Two of them resulted in a failure. The time to failure cannot be given since the autoclave are only opened after 720 h. A fracture occurred under dry hydrogen (120 bar  $H_2$ ) conditions at room temperature and under the more severe conditions in gas D (120 bar  $H_2$  + 15 bar CO<sub>2</sub> + 1 bar  $H_2$ S) with an electolyte. This is shown in Figure 1. No failure occurred unter dry hydrogen (120 bar  $H_2$ ) conditions at 120 °C.

Figure 1: Time to failure of quenched material after testing in gas A (120 bar  $H_2$ ), no electrolyte, at room temperature and 120 °C & in gas D (120 bar  $H_2$  + 15 bar CO<sub>2</sub> + 1 bar  $H_2$ S), 200 g/l NaCl, immersion in gas + electrolyte, 120 °C.

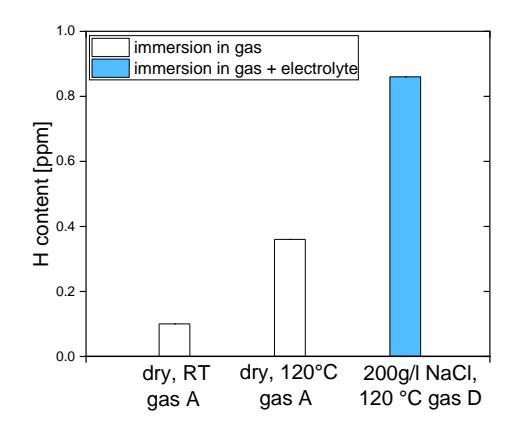
Figure 2: Hydrogen uptake of quenched material after testing in gas A (120 bar  $H_2$ ), no electrolyte, at room temperature and 120 °C & in gas D (120 bar  $H_2$  + 15 bar CO<sub>2</sub> + 1 bar  $H_2$ S), 200 g/l NaCl, immersion in gas + electrolyte, 120 °C.

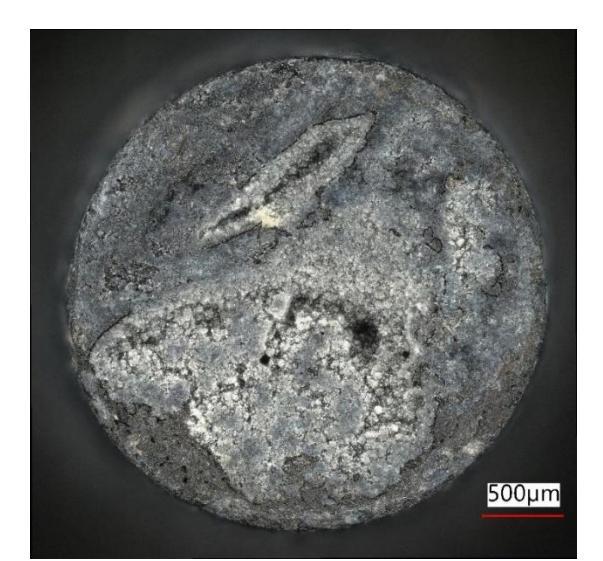
Figure 3 shows a fracture image of a quenched steel. The test condition was the more aggressive one in gas D ( $H_2 + CO_2 + H_2S$ ) with an electrolyte of 200 g/l sodium chloride NaCl at 120°C. Under these severe conditions a fracture occurred. It did not make sense to make a SEM examination with this fracture surface, because the surface is covered by a thick layer of corrosion products. The hydrogen content in the specimen was 0.86 ppm after the experiment.

Figure 3: Fracture surface of quenched steel tested in gas D (120 bar  $H_2$  + 15 bar CO2 + 1 bar  $H_2$ S), 200 g/l NaCl, immersion in gas + electrolyte, 120 °C.

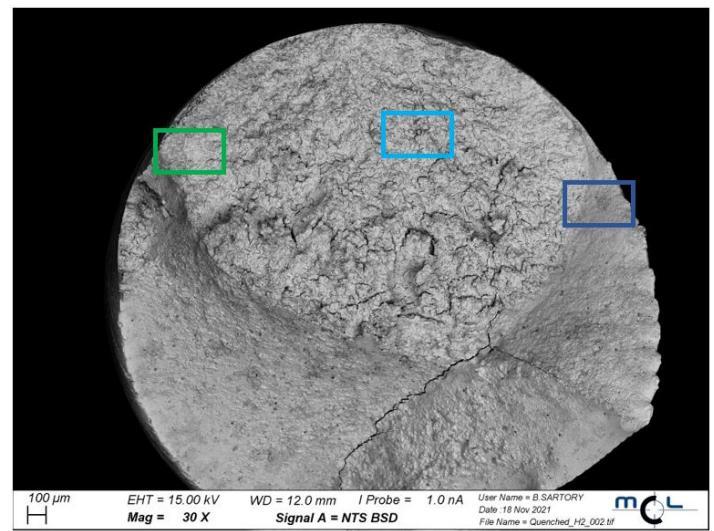
Figure 4 shows a fracture image of the quenched steel tested under milder conditions. The test condition was dry gas A ( $H_2$ ) at room temperature. Under these conditions also a fracture occurred. At the 12 o´clock position the fracture origin is observed. A hydrogen amount of only 0.10 ppm was measured using TDS.

Figure 4: Fracture surface of quenched steel tested in gas A (120 bar H<sub>2</sub>), no electrolyte, 25 °C, 30x.

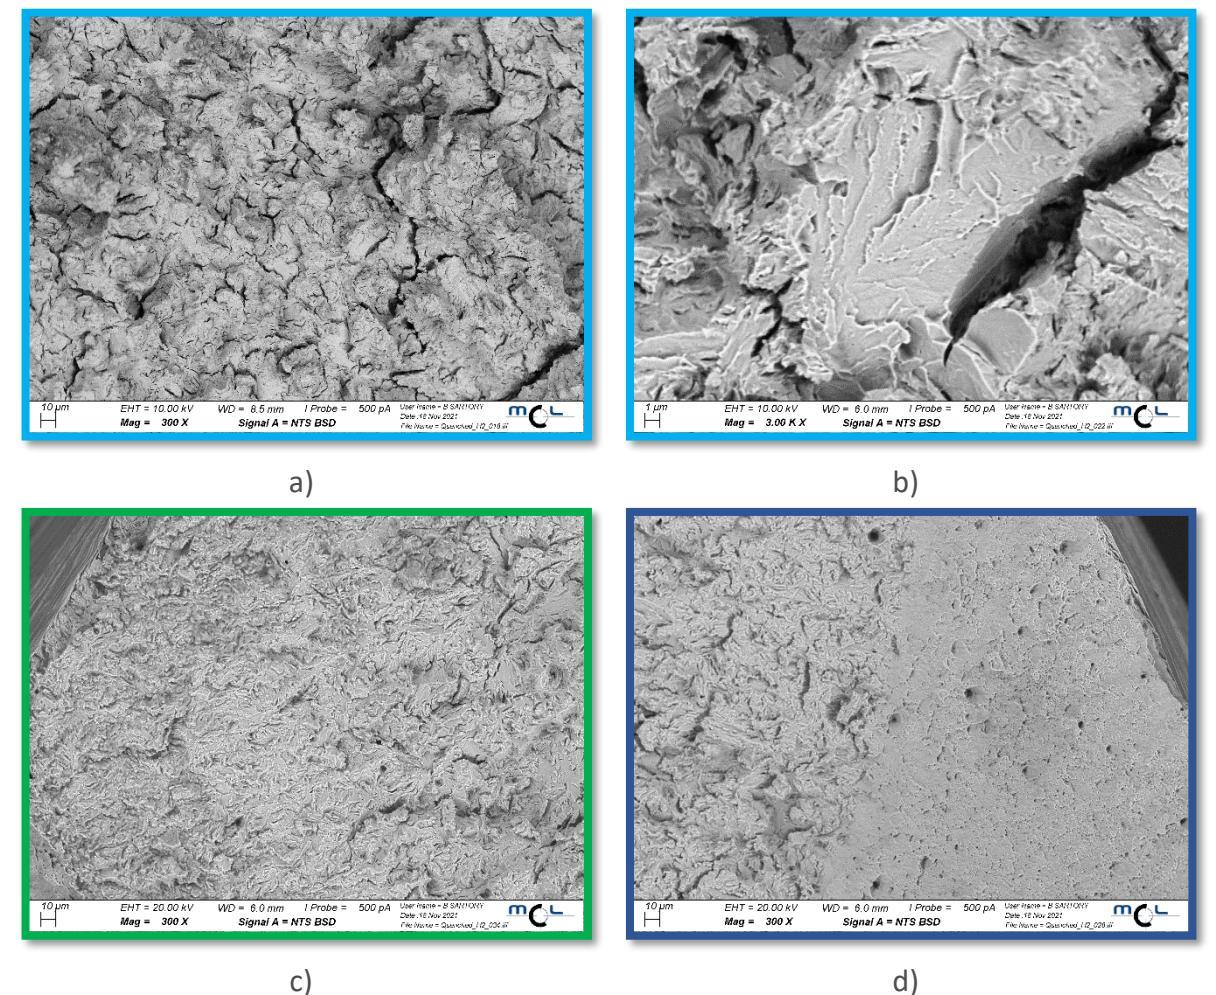
Figure 5 shows the different fracture zones in a SEM. In Figure 5 a), in the light blue frame from Figure 4, a clear hydrogen fracture is present. There are ductile and brittle zones present. Figure 4 b) is a higher magnification. There is a cleavage like fracture with river patterns and some fine pores typical for a hydrogen induced fracture. In Figure 5 c) the green area shows a brittle fracture as well. In the dark blue area from Figure 4 and magnified in Figure 5 d), the transition area between brittle hydrogen crack and a ductile forced fracture is visible.

Figure 5: Details of fracture surface of quenched steel a) hydrogen fracture 300x, b) river patterns at hydrogen fracture 3000x, c) hydrogen fracture 300x d) transition zone between hydrogen fracture (left) and ductile forced fracture (right), 300x.

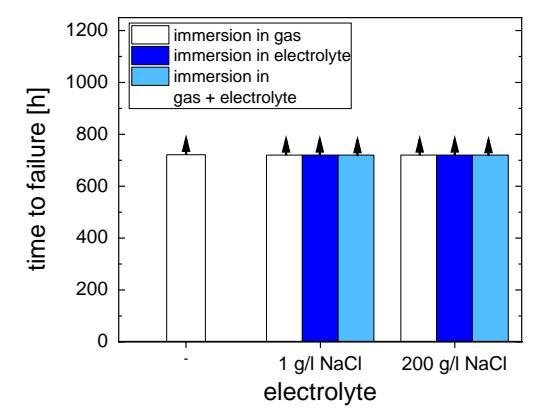
Figure 6 shows the time to failure of ferritic perlitic steel K55 for all gas compositions. Gases without  $H_2S$  (non-sour gas) are gas A (120 bar  $H_2$ ) and gas B (120 bar  $H_2 + 15$  bar  $CO_2$ ). Gases with  $H_2S$  (sour gas) are gas C (120 bar  $H_2 + 1$  bar  $H_2S$ ) and gas D (120 bar  $H_2 + 15$  bar  $CO_2 + 1$  bar  $H_2S$ ). No fracture at all occurred under any condition. Figure 6 below shows as an example of time to failure in gas D. No cracks at all occurred in specimens of steel K55. The same happened for gases A, B and C and at room temperature and at 120 °C.

Figure 6: Time to failure of ferritic perlitic steel K55 in gas D: 120 bar  $H_2$  + 15 bar  $CO_2$  + 1 bar  $H_2S$ , 25 °C.

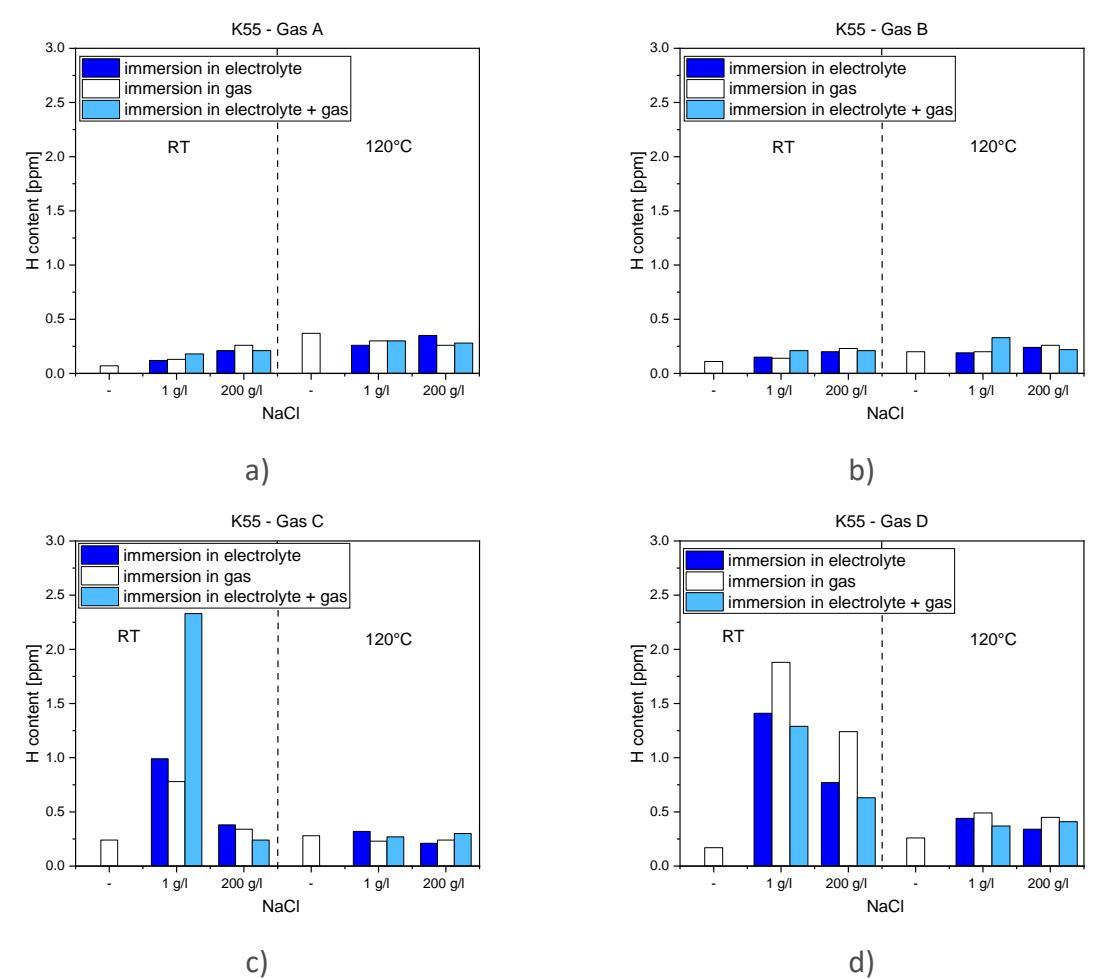
In this autoclave tests with steel K55 at room temperature, the lowest hydrogen value is 0.07 ppm for gas A and the highest value is 2.33 ppm for immersion in gas C. Gases A and B show no increased hydrogen uptake. Gases C and D with H<sub>2</sub>S show increased values whenever an electrolyte is present. When no electrolyte is present, H<sub>2</sub>S has almost no effect on hydrogen uptake. In gases C and D higher hydrogen contents were generated with the presence of an electrolyte. However, no failure occurred. In the autoclave tests with the steel K55 at 120 °C, the lowest value is 0.19 ppm in gas B and the highest value is 0.49 ppm in gas D, in comparison, the blank value is 0.22 ppm. The hydrogen content was measured by thermal desorption spectroscopy (TDS).

Figure 7: Hydrogen content after immersion of steel K55 in various gases, electrolytes and salinities at different temperatures for 30 days; a) and b) are without  $H_2S$ ; c) and d) are with  $H_2S$ ; a) gas A (120 bar  $H_2$ ), b) gas B (120 bar  $H_2 + 15$  bar  $CO_2$ ), c) gas C (120 bar  $H_2 + 1$  bar  $H_2S$ ) and d) gas D (120 bar  $H_2 + 15$  bar  $CO_2 + 1$  bar  $H_2S$ ).

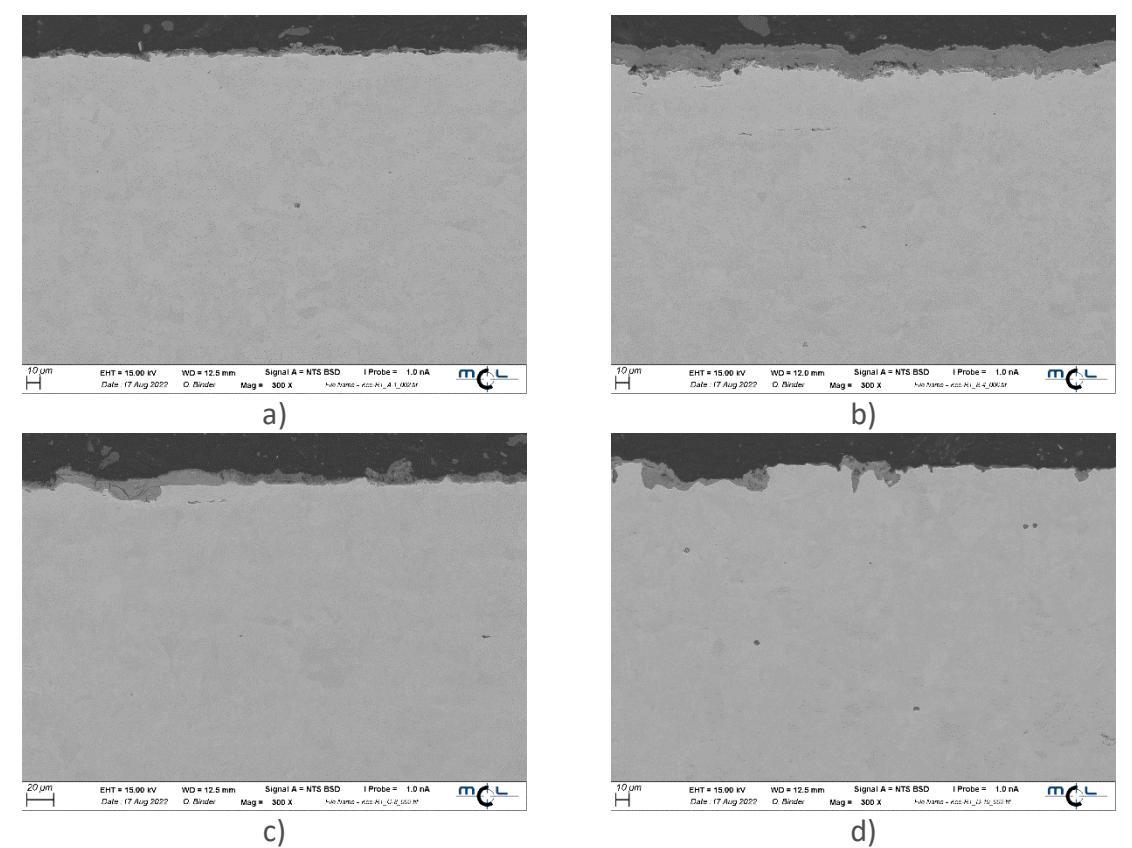
Figure 8 a) and b) show a cross-section of the ferritic and pearlitic steel K55 in the SEM at a magnification of 300x in gases without  $H_2S$  (non-sour gas). Figure 8 c) and d) show the cross section of the steel K55 but at gases with  $H_2S$  (sour gas). Figure 9 shows the same conditions as Figure 8 but at higher temperature.

Figure 8: SEM analysis of the surface of steel K55 at room temperature after 720 hours of autoclave testing with 200 g/l NaCl in a) and b) are without  $H_2S$ ; c) and d) are with  $H_2S$ ; a) gas A (120 bar  $H_2$ ), b) gas B (120 bar  $H_2$  + 15 bar CO2), c) gas C (120 bar  $H_2$  + 1 bar  $H_2S$ ) and d) gas D (120 bar  $H_2$  + 15 bar CO2 + 1 bar  $H_2S$ ).

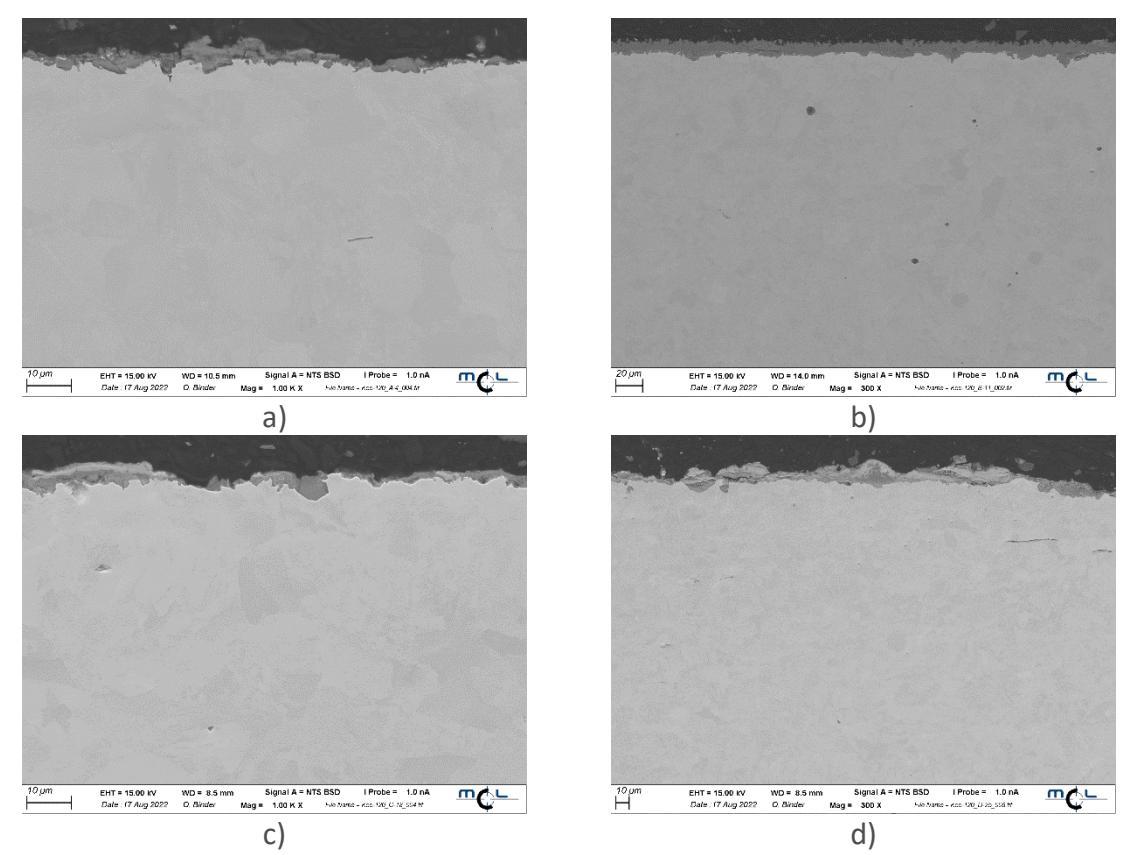
Figure 9: SEM analysis of the surface of steel K55 at 120 °C after 720 hours of autoclave testing with 200 g/l NaCl in a) and b) are without  $H_2S$ ; c) and d) are with  $H_2S$ ; a) gas A (120 bar  $H_2$ ), b) gas B (120 bar  $H_2 + 15$  bar CO2), c) gas C (120 bar  $H_2 + 1$  bar  $H_2S$ ) and d) gas D (120 bar  $H_2 + 15$  bar CO2 + 1 bar  $H_2S$ ).

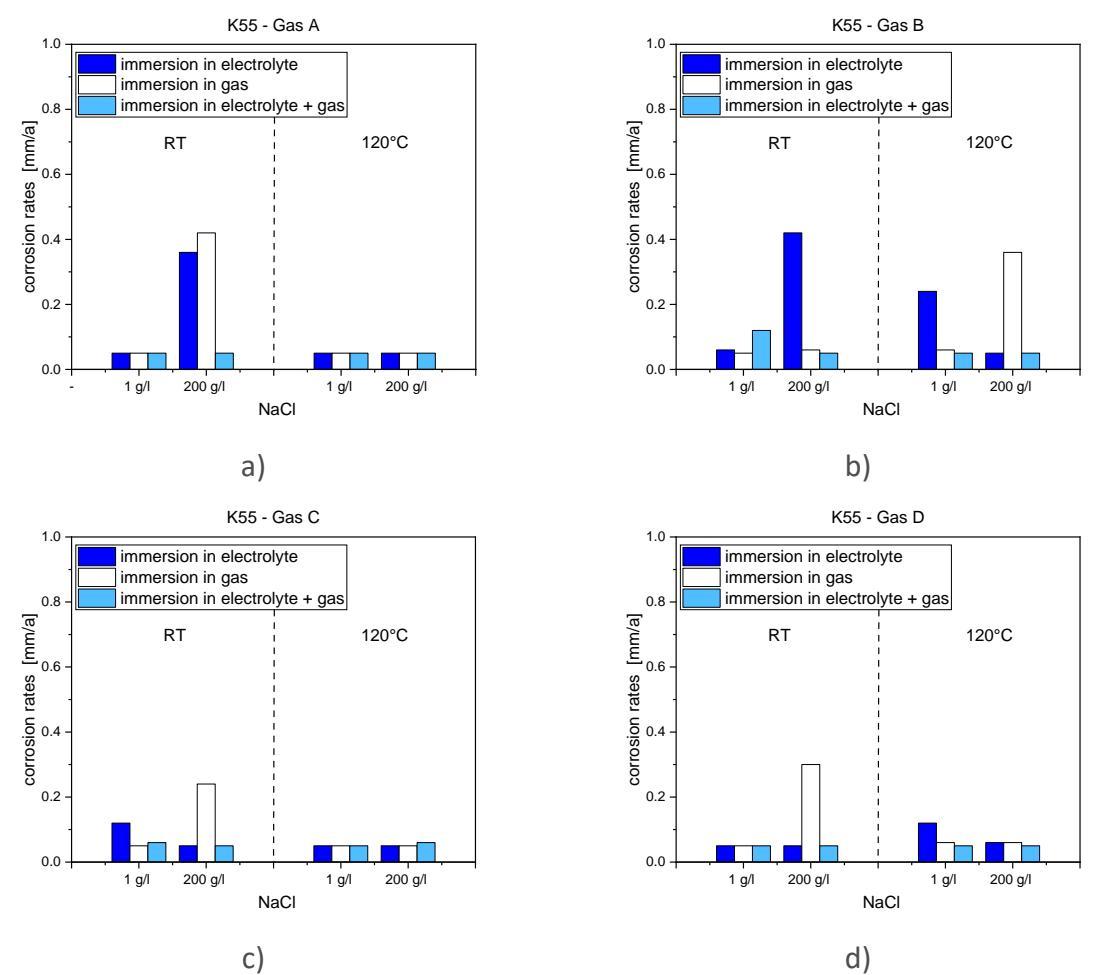
Figure 10 a) and b) show the corrosion rate of the ferritic - pearlitic steel K55 in gases without  $H_2S$  (non-sour gas). Figure 10 c) and d) show the corrosion rate of this steel in Gases with  $H_2S$  (sour gas).

Figure 10: Corrosion rate of steel K55 in autoclave tests at different temperatures a) and b) are without  $H_2S$ ; c) and d) are with  $H_2S$  in; a) gas A (120 bar  $H_2$ ), b) gas B (120 bar  $H_2$  + 15 bar CO2), c) gas C (120 bar  $H_2$  + 1 bar  $H_2S$ ) and d) gas D (120 bar  $H_2$  + 15 bar CO2 + 1 bar  $H_2S$ ).

Corrosion rate are mainly below 0.1 mm/y for most conditions. Some experiments yielded to a higher corrosion rate up to 0.4 mm/y. However there are no preferential conditions that resulted in a higher corrosion rate, such as higher temperature, higher salinity, presence of  $H_2S$  or immersion of the specimens in the electrolyte. The higher corrosion rates are randomly distributed among the results and therefore it is believed that there is some scatter.

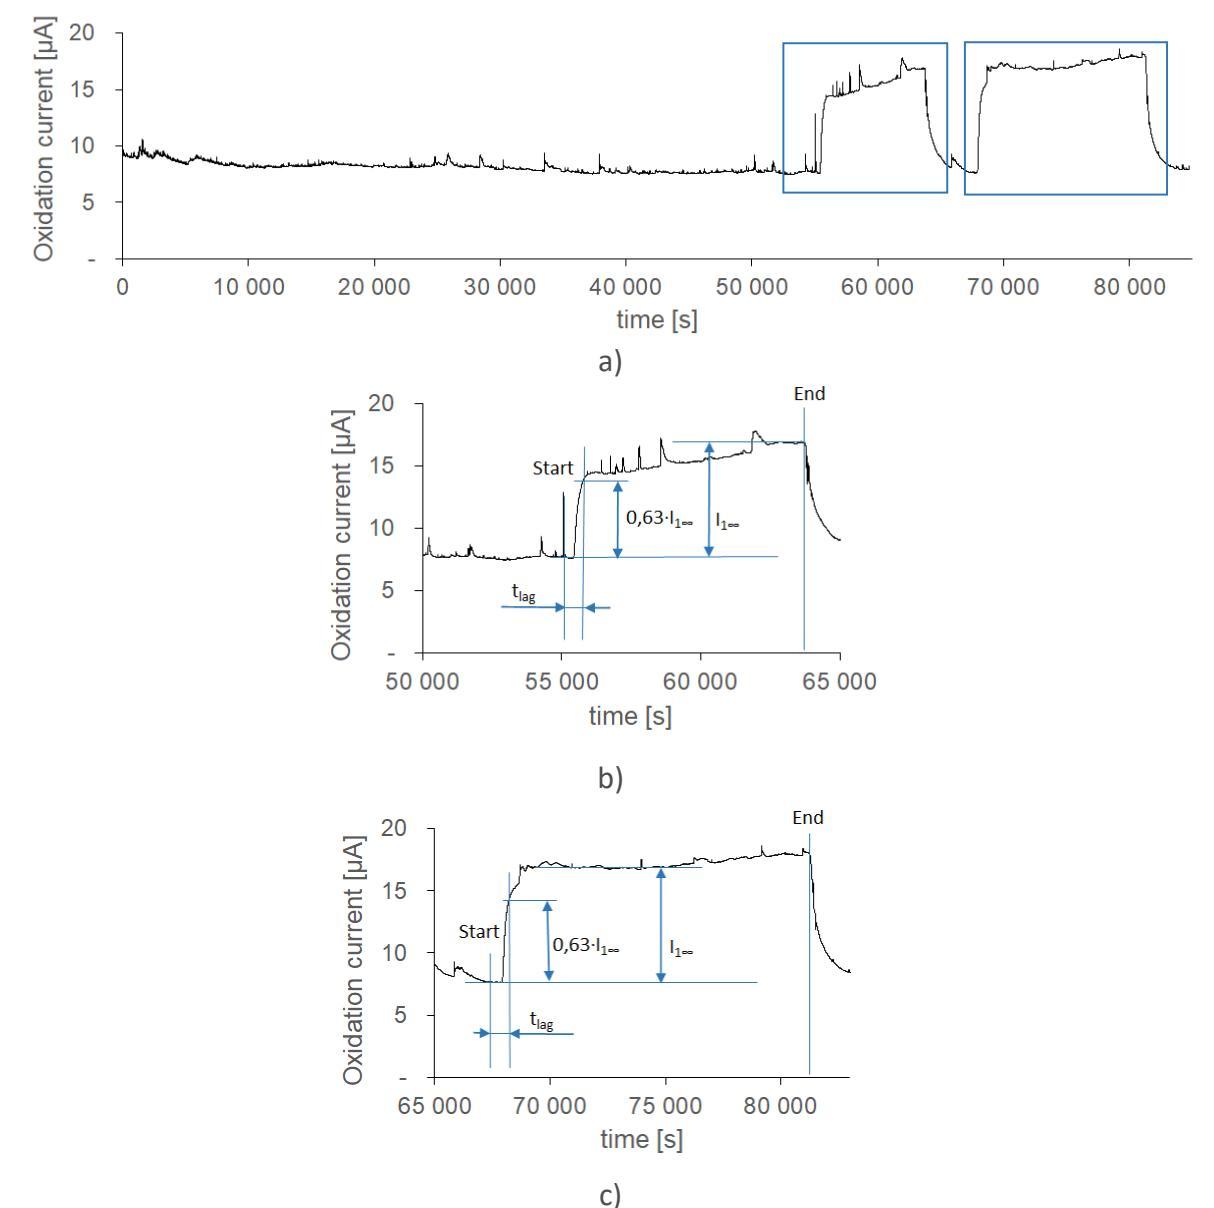
Figure 11: Hydrogen permeation current as function of time for 2 consecutive loadings for steel K55, Oxidation cell with 0.1M NaOH and the charging cell with 3.5%NaCl + 1 g/l Thiourea a) overview of two charging cycles, b) detail of 1<sup>st</sup> charging, c) detail of 2<sup>nd</sup> charging.

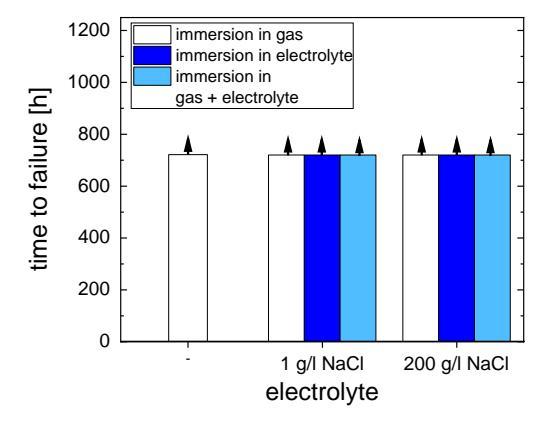
Figure 12 shows the time to failure of tempered martensite steel L80 for all gas compositions. No fracture occurred under any condition. Figure 12 shows as an example time to failure in gas D at room temperature. No cracks at all occurred for the steel L80. The same happened for gases A, B and C.

Figure 12: Time to failure of a tempered martensitic steel L80 in gas D: 120 bar  $H_2$  + 15 bar  $CO_2$  + 1 bar  $H_2S$ , 25 °C.

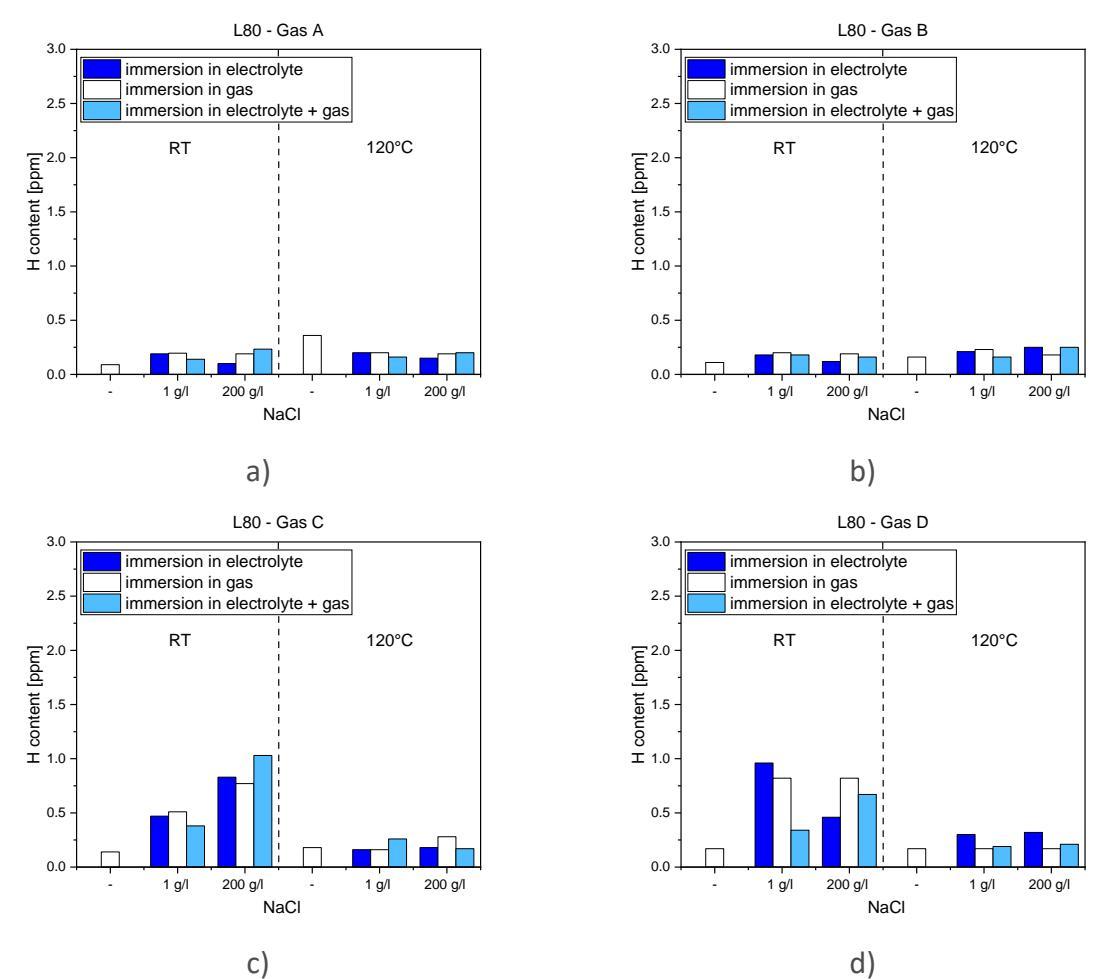
Figure 13: Hydrogen content after immersion of steel L80 in various gases, electrolytes and salinities at different temperatures for 30 days; a) and b) are without  $H_2S$ ; c) and d) are with  $H_2S$ ; a) gas A (120 bar  $H_2$ ), b) gas B (120 bar  $H_2 + 15$  bar  $CO_2$ ), c) gas C (120 bar  $H_2 + 1$  bar  $H_2S$ ) and d) gas D (120 bar  $H_2 + 15$  bar  $CO_2 + 1$  bar  $H_2S$ ).

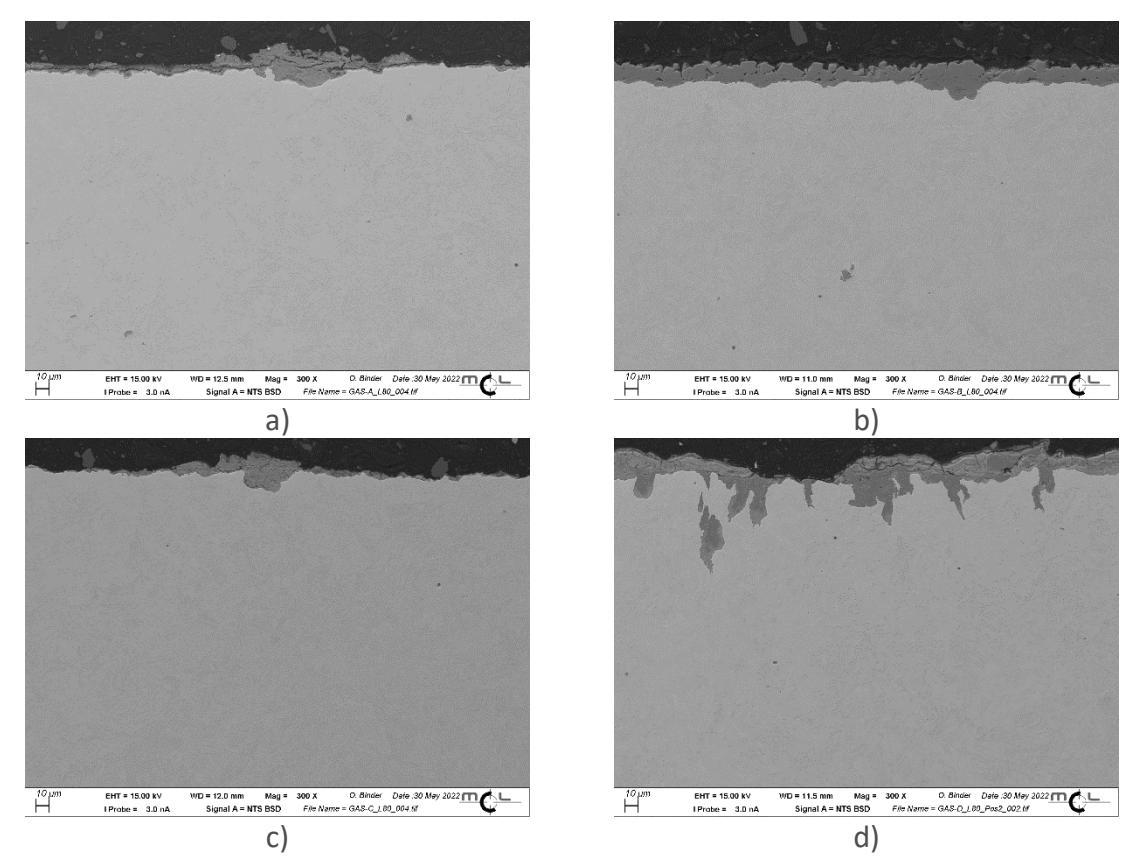
Figure 15: SEM analysis of the surface of steel L80 at 120 °C after 720 hours of autoclave testing with 200 g/l NaCl in a) and b) are without  $H_2S$ ; c) and d) are with  $H_2S$ ; a) gas A (120 bar  $H_2$ ), b) gas B (120 bar  $H_2 + 15$  bar CO<sub>2</sub>), c) gas C (120 bar  $H_2 + 1$  bar  $H_2S$ ) and d) gas D (120 bar  $H_2 + 15$  bar CO<sub>2</sub> + 1  $H_2S$ ).

There are no obvious defects in any of the cross-sections, except one. The cross-section of steel L80 in Figure 15 d) shows localized attack on the surface, at higher pressures and when hydrogen sulphide is present. The approximate maximum depth of attack is 68  $\mu$ m, although it cannot be excluded that deeper attack may be found at another point on the sample. The material seems to be durable under tested conditions and is suitable for use in pure hydrogen applications. In presence of high content of H<sub>2</sub>S (partial pressure of 1 bar), localized defects might appear. Nevertheless, according to the standard ISO 15156-2, L80 is applicable for H<sub>2</sub>S service provided that it is type 1.

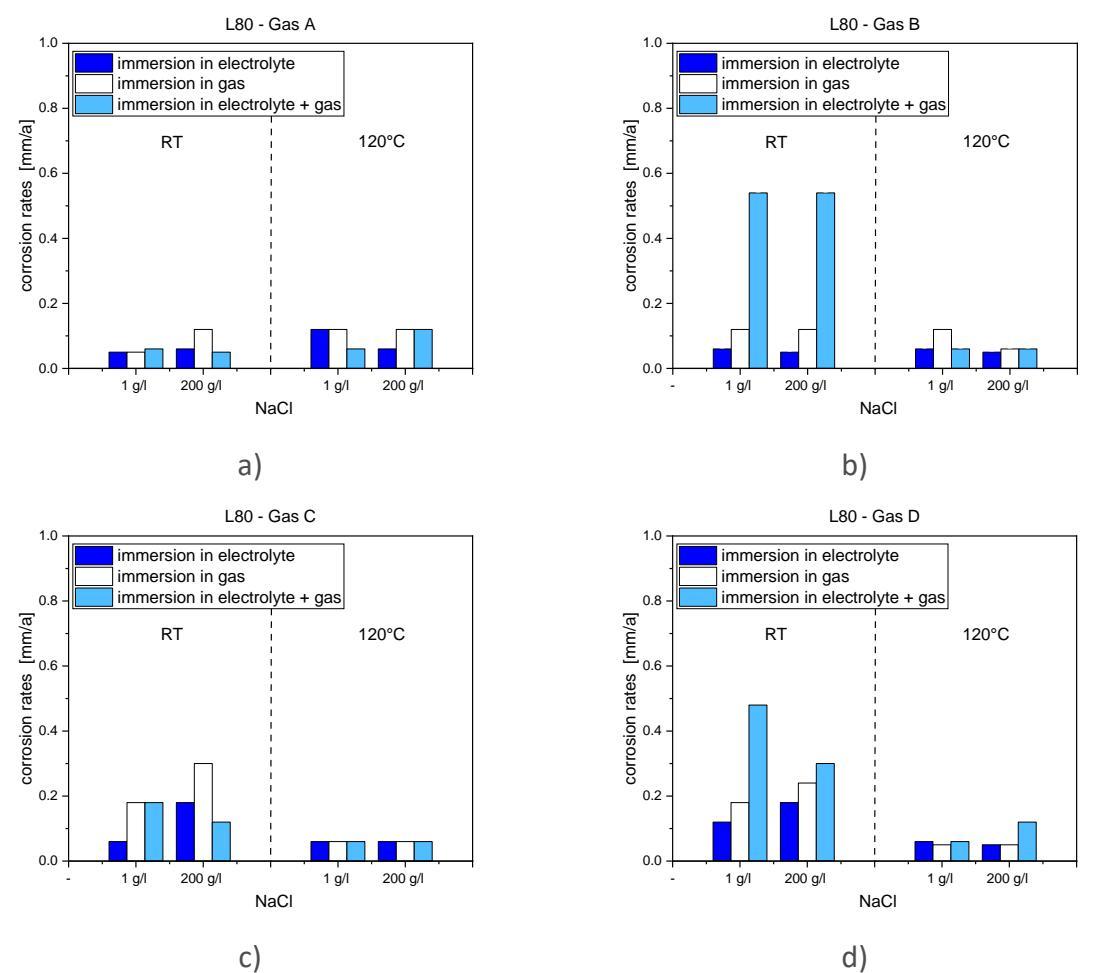
Figure 16 a) and b) show the corrosion rate of the tempersteel L80 in gases without  $H_2S$  (non-sour gas). Figure 16 c) and d) show the corrosion rate of the steel L80 but at Gases with  $H_2S$  (sour gas).

Figure 16: Corrosion rate of steel L80 in autoclave tests at different temperatures in a) and b) are without  $H_2S$ ; c) and d) are with  $H_2S$  in; a) gas A (120 bar  $H_2$ ), b) gas B (120 bar  $H_2$  + 15 bar  $CO_2$ ), c) gas C (120 bar  $H_2$  + 1 bar  $H_2S$ ) and d) gas D (120 bar  $H_2$  + 15 bar  $CO_2$  + 1  $H_2S$ ).

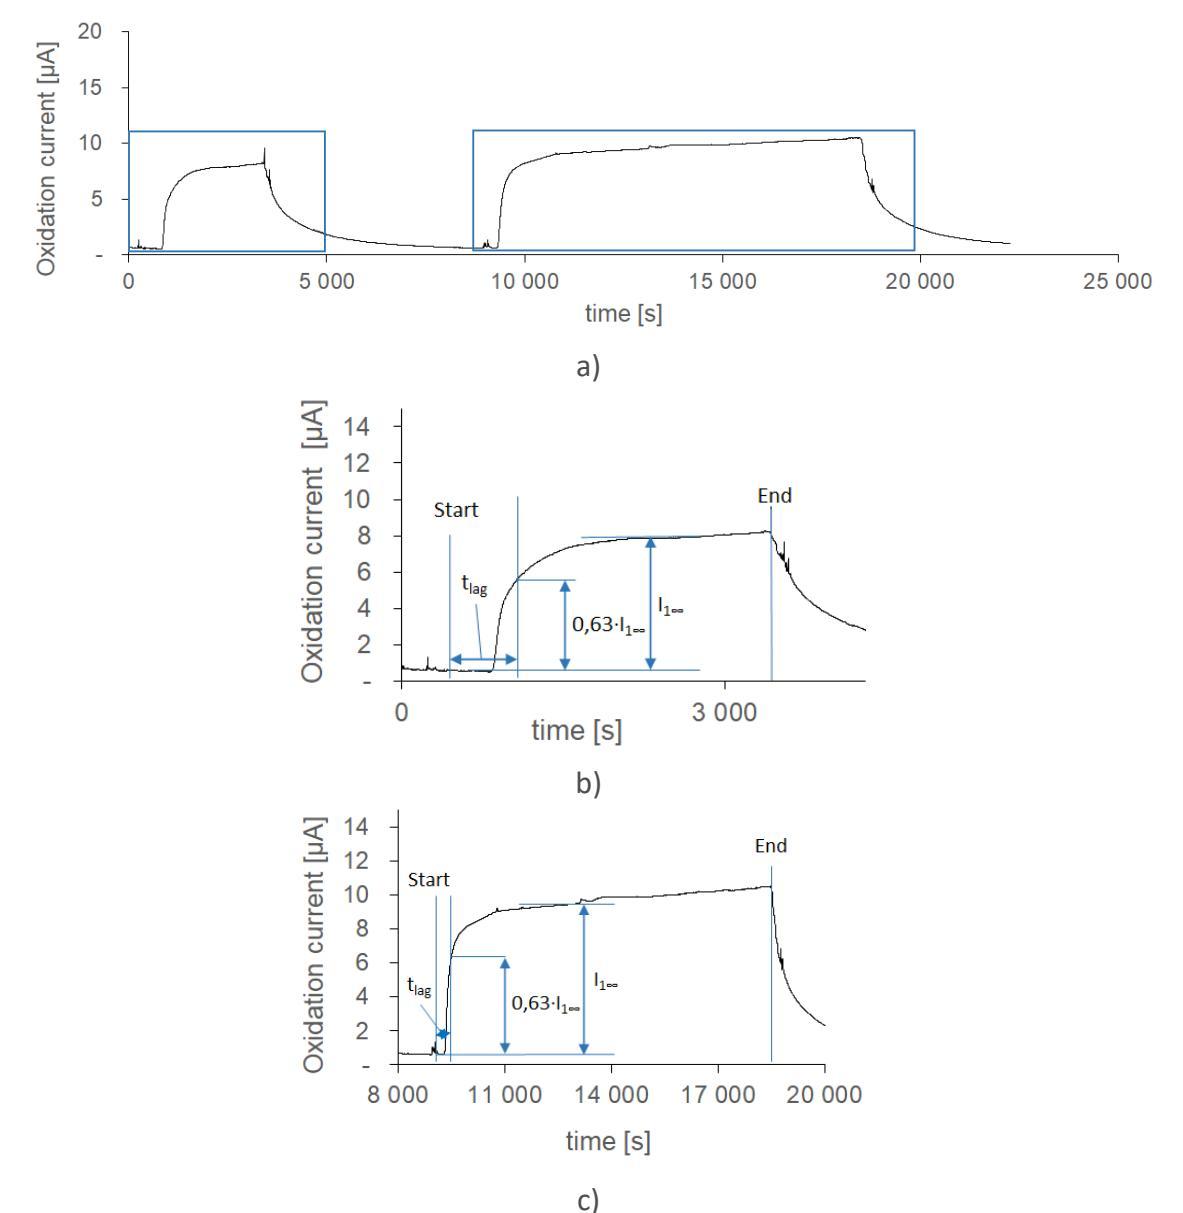
Figure 17: Hydrogen permeation current as function of time for 2 consecutive loadings for steel L80, Oxidation cell with 0.1M NaOH and the charging cell with 3.5%NaCl + 1 g/l Thiourea a) overview of two charging cycles, b) detail of 1st charging, c) detail of  $2^{nd}$  charging.

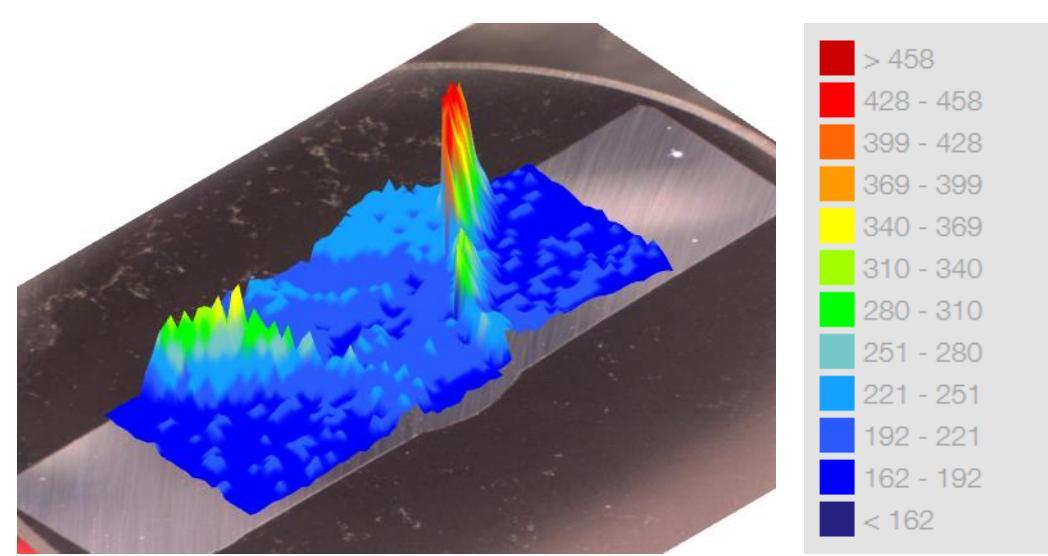
Figure 18: Hardness mapping according to Vickers HV1 for the welded steel J55.

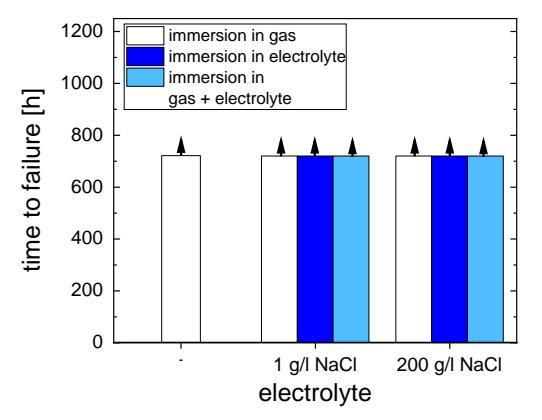
Figure 19: Time to failure of a ferritic pearlitic welded steel J55 in gas D: 120 bar  $H_2$  + 15 bar  $CO_2$  + 1 bar  $H_2S$ , 25 °C.

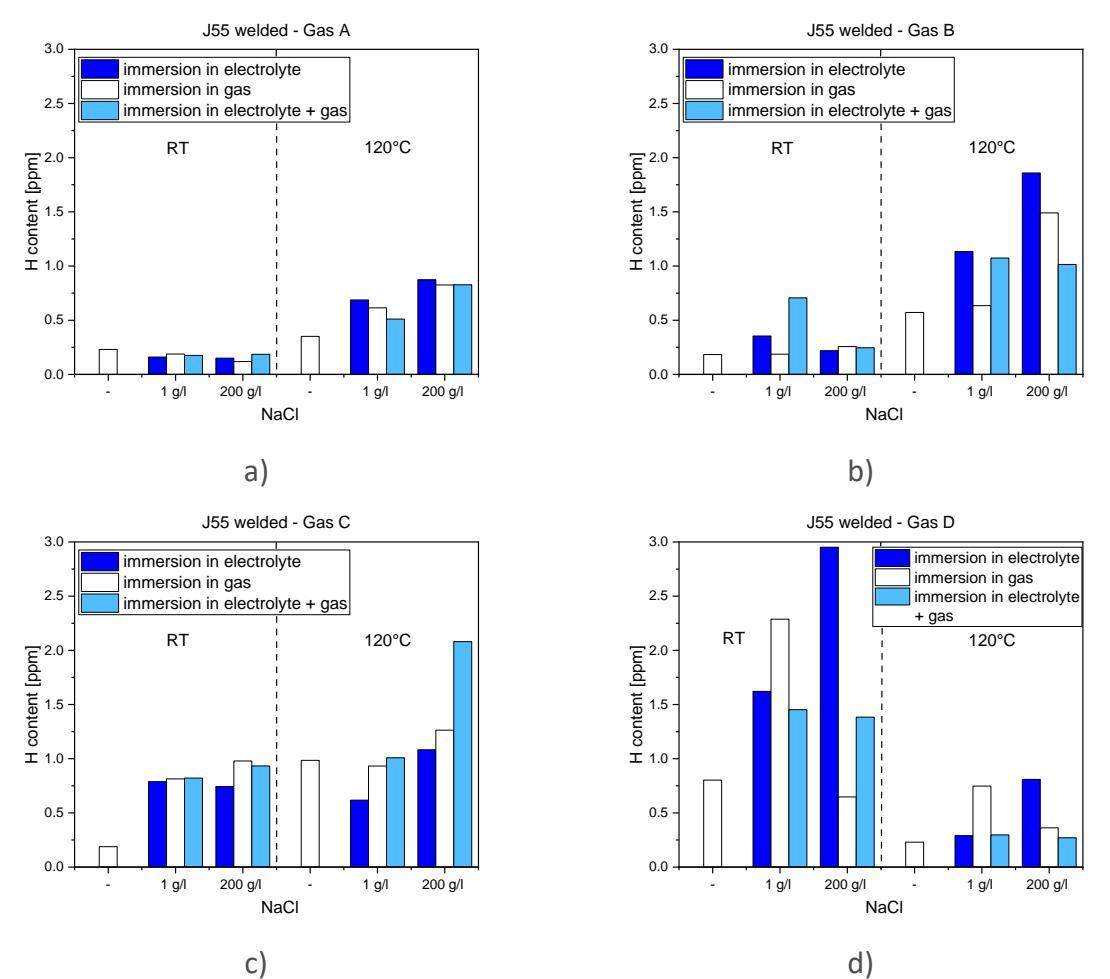
Figure 20: Hydrogen content after immersion of a welded steel J55 in various gases, electrolytes and salinities at different temperatures for 30 days; a) and b) are without  $H_2S$ ; c) and d) are with  $H_2S$ ; a) gas A (120 bar  $H_2$ ), b) gas B (120 bar  $H_2 + 15$  bar  $CO_2$ ), c) gas C (120 bar  $H_2 + 1$  bar  $H_2S$ ) and d) gas D (120 bar  $H_2 + 15$  bar  $CO_2 + 1$  bar  $H_2S$ ).

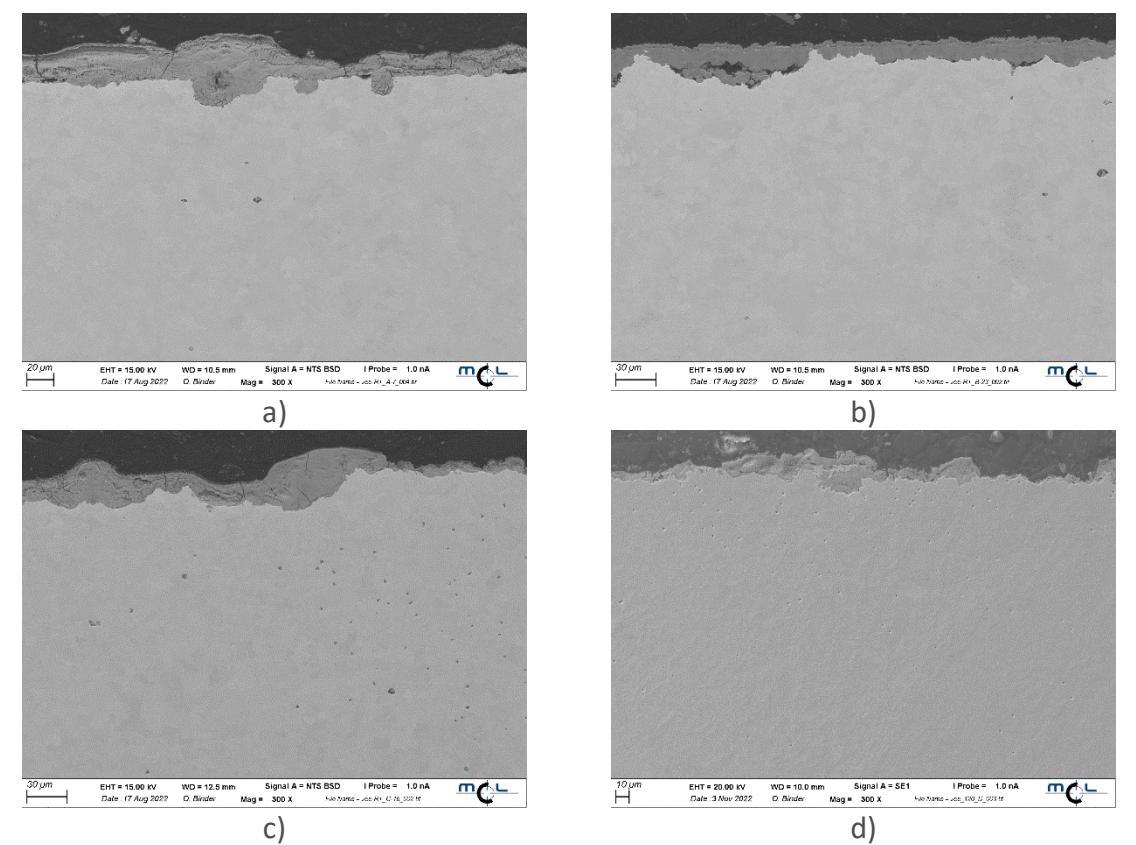
Figure 21: SEM analysis of the surface of a welded steel J55 at room temperature after 720 hours of autoclave testing with 200 g/l NaCl in a) and b) are without  $H_2S$ ; c) and d) are with  $H_2S$ ; a) gas A (120 bar  $H_2$ ), b) gas B (120 bar  $H_2 + 15$  bar  $CO_2$ ), c) gas C (120 bar  $H_2 + 1$  bar  $H_2S$ ) and d) gas D (120 bar  $H_2 + 15$  bar  $CO_2 + 1$   $H_2S$ ).

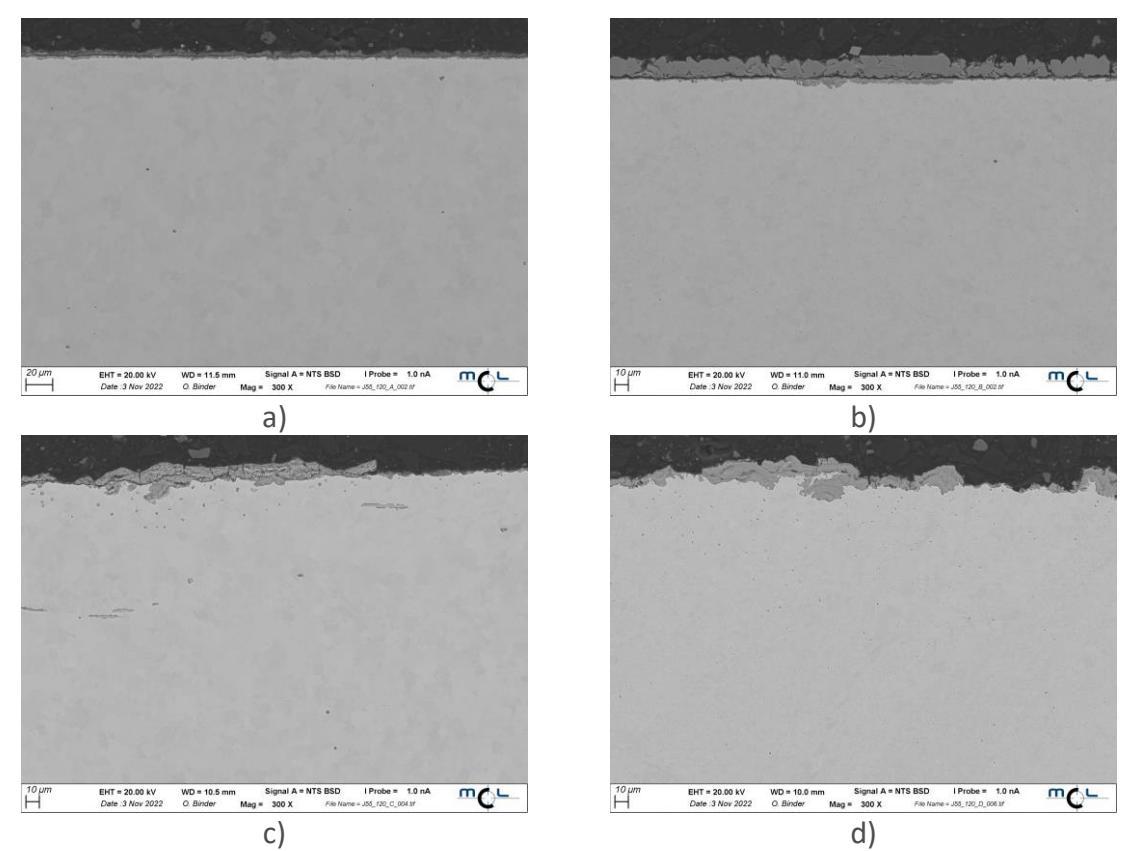
Figure 22: SEM analysis of the surface of a welded steel J55 at 120 °C after 720 hours of autoclave testing with 200 g/l NaCl in a) and b) are without  $H_2S$ ; c) and d) are with  $H_2S$ ; a) gas A (120 bar  $H_2$ ), b) gas B (120 bar  $H_2 + 15$  bar  $CO_2$ ), c) gas C (120 bar  $H_2 + 1$  bar  $H_2S$ ) and d) gas D (120 bar  $H_2 + 15$  bar  $CO_2 + 1$   $H_2S$ ).

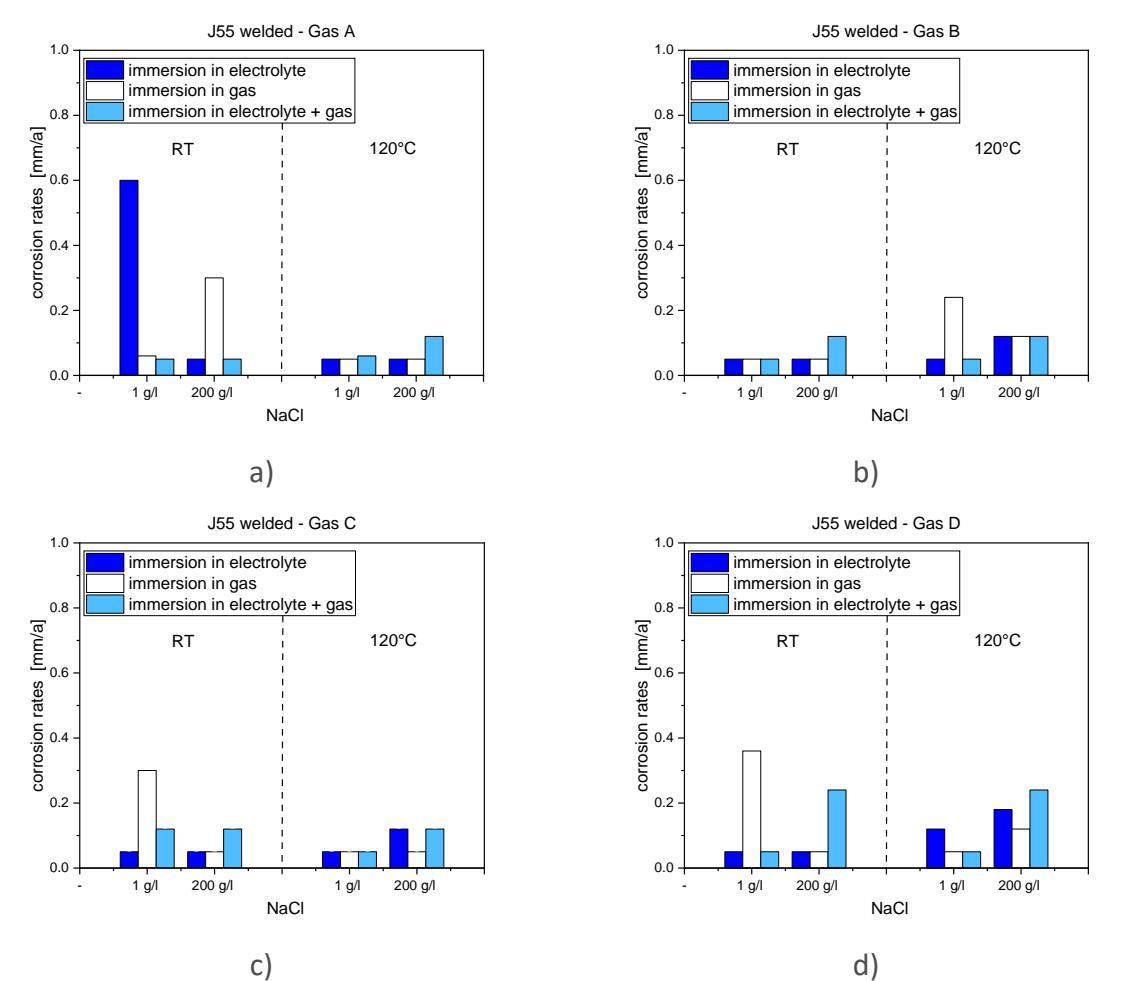
Figure 23: Corrosion rate of steel J55 welded in autoclave tests at different temperatures a) and b) are without  $H_2S$ ; c) and d) are with  $H_2S$  in; a) gas A (120 bar  $H_2$ ), b) gas B (120 bar  $H_2 + 15$  bar  $CO_2$ ), c) gas C (120 bar  $H_2 + 1$  bar  $H_2S$ ) and d) gas D (120 bar  $H_2 + 15$  bar  $CO_2 + 15$  bar  $CO_2 + 15$  bar  $H_2S$ ).

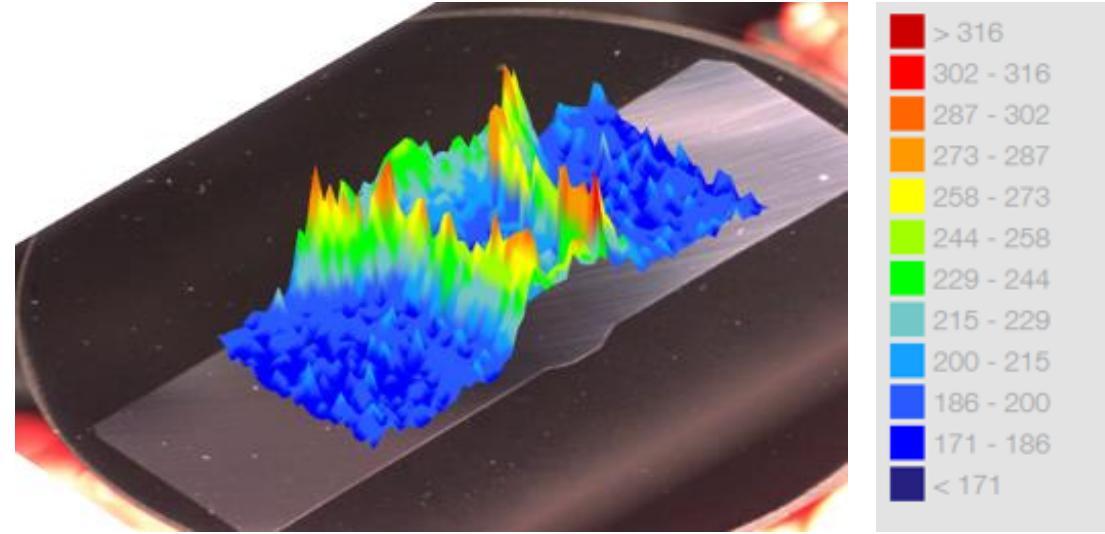
Figure 25: Hardness mapping according to Vickers HV1 for the welded steel K55.

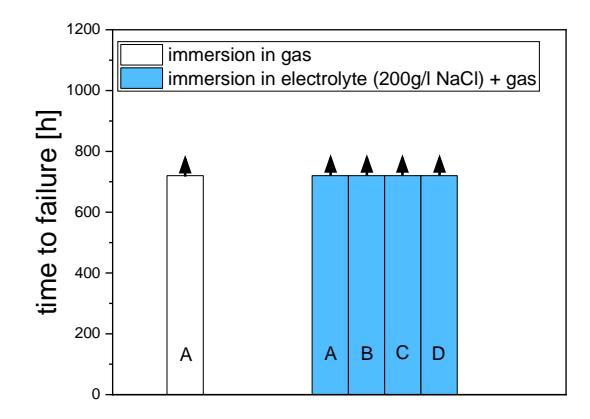
Figure 26: Time to failure of steel K55 welded in autoclave tests at room temperarture in gas A (120 bar  $H_2$ ), gas B (120 bar  $H_2 + 15$  bar  $CO_2$ ), gas C (120 bar  $H_2 + 1$  bar  $H_2S$ ) and gas D (120 bar  $H_2 + 15$  bar  $CO_2 + 1$  bar  $H_2S$ ) with an electrolyte 200 g/l NaCl rotating and one dry condition with gas A (120 bar  $H_2$ ).

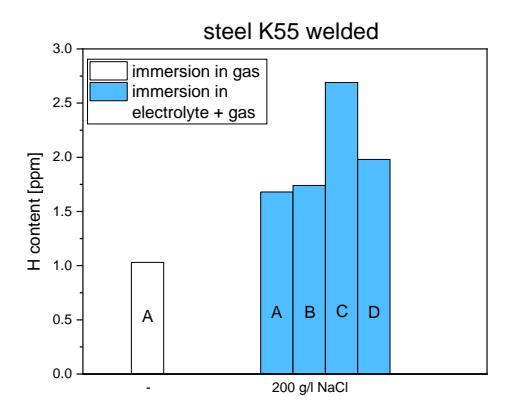
Figure 27: Hydrogen uptake of steel K55 welded in autoclave tests at RT in gas A (120 bar  $H_2$ ), gas B (120 bar  $H_2 + 15$  bar  $CO_2$ ), gas C (120 bar  $H_2 + 1$  bar  $H_2S$ ) and gas D (120 bar  $H_2 + 15$  bar  $CO_2 + 1$  bar  $H_2S$ ) with an electrolyte 200 g/l NaCl rotating and one dry condition with gas A (120 bar  $H_2$ ).
