# Summary report on all investigated steels

Dissemination level: PU - Public Hystories deliverable D4.6-0 Date: 16 March 2023

Bernd LODER

Montanuniversitaet Leoben, Austria

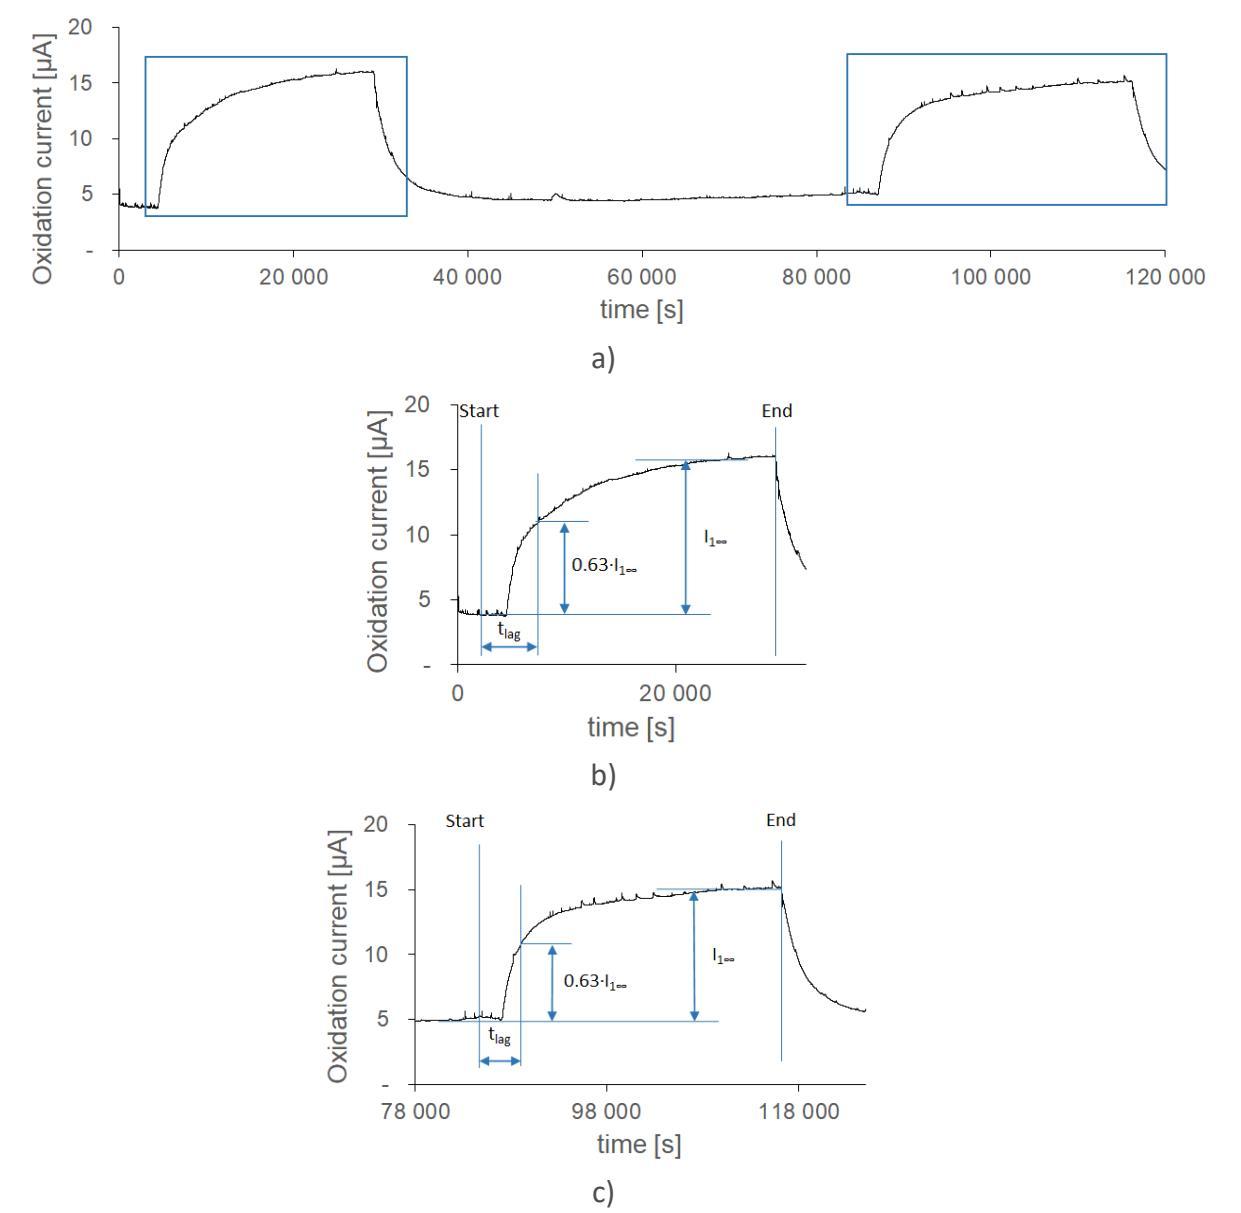
Figure 29: Hydrogen permeation current as function of time for 2 consecutive loadings for steel K55, Oxidation cell with 0.1M NaOH and the charging cell with 3.5%NaCl + 1 g/l Thiourea a) overview of two charging cycles, b) detail of 1st charging, c) detail of  $2^{nd}$  charging.

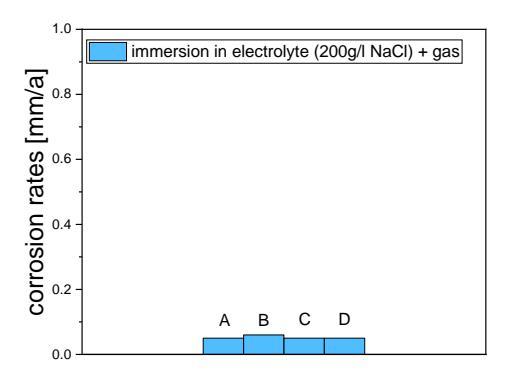
Figure 30: Hydrogen uptake of steel K55 welded in autoclave tests at RT in gas A (120 bar  $H_2$ ), gas B (120 bar  $H_2$  + 15 bar  $CO_2$ ), gas C (120 bar  $H_2$  + 1 bar  $H_2S$ ) and gas D (120 bar  $H_2$  + 15 bar  $CO_2$  + 1 bar  $H_2S$ ) with an electrolyte 200 g/l NaCl rotating and one dry condition with gas A (120 bar  $H_2$ ).

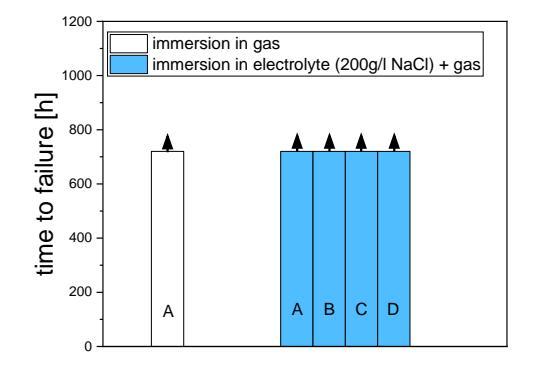
Figure 31: Time to failure of a tempered martensitic steel P110 at room temperature in gas A (120 bar  $H_2$ ), gas B (120 bar  $H_2$  + 15 bar  $CO_2$ ), gas C (120 bar  $H_2$  + 1 bar  $H_2S$ ) and gas D (120 bar  $H_2$  + 15 bar  $CO_2$  + 1 bar  $H_2S$ ) with an electrolyte 200 g/l NaCl rotating and one dry condition with gas A (120 bar  $H_2$ ).

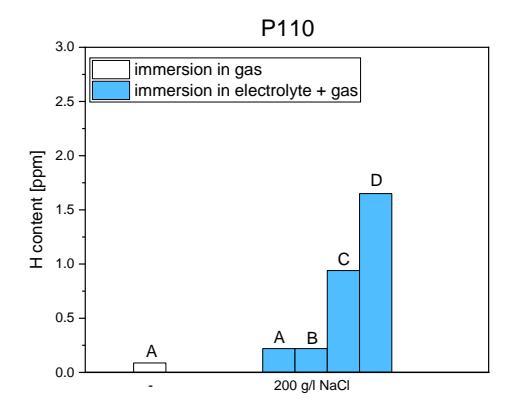
Figure 32: Hydrogen uptake of steel P110 in autoclave tests at RT in gas A (120 bar  $H_2$ ), gas B (120 bar  $H_2 + 15$  bar  $CO_2$ ), gas C (120 bar  $H_2 + 1$  bar  $H_2S$ ) and gas D (120 bar  $H_2 + 15$  bar  $CO_2 + 1$  bar H2S) with an electrolyte 200 g/l NaCl rotating and one dry condition with gas A (120 bar  $H_2$ ).

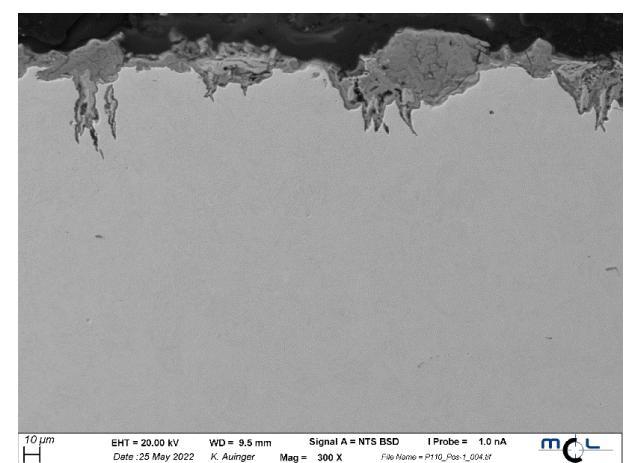
Figure 33: Cross-section of steel P110 at magnification 300x, with Gas D containing 200g/I NaCl at RT.

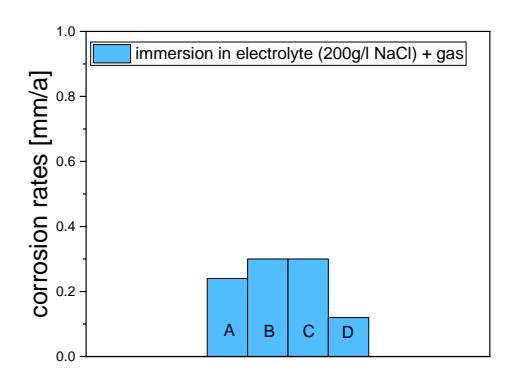
Figure 34: Hydrogen uptake of steel P110 in autoclave tests at RT in gas A (120 bar  $H_2$ ), gas B (120 bar  $H_2 + 15$  bar  $CO_2$ ), gas C (120 bar  $H_2 + 1$  bar  $H_2S$ ) and gas D (120 bar  $H_2 + 15$  bar  $CO_2 + 1$  bar  $H_2S$ ) with an electrolyte 200 g/l NaCl rotating.

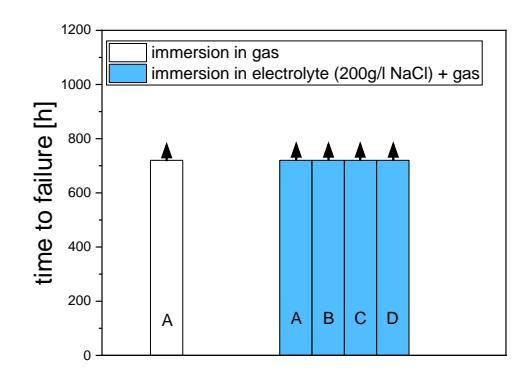
Figure 35: Time to failure of a ferritic pearlitic steel 20MnV5 at room temperature in gas A (120 bar  $H_2$ ), gas B (120 bar  $H_2 + 15$  bar  $CO_2$ ), gas C (120 bar  $H_2 + 1$  bar  $H_2S$ ) and gas D (120 bar  $H_2 + 15$  bar  $CO_2 + 1$  bar  $H_2S$ ) with an electrolyte 200 g/l NaCl rotating and one dry condition with gas A (120 bar  $H_2$ ).

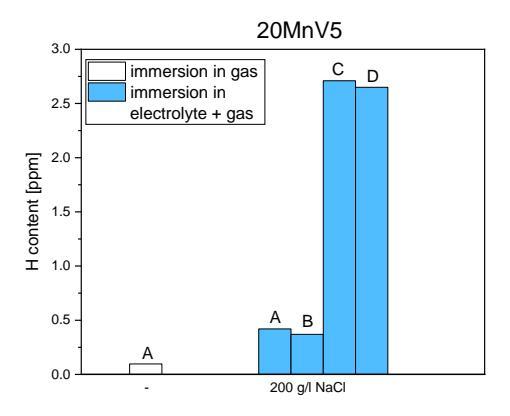
Figure 36: Hydrogen content of a ferritic pearlitic steel 20MnV5 at room temperature in gas A (120 bar  $H_2$ ), gas B (120 bar  $H_2$  + 15 bar CO<sub>2</sub>), gas C (120 bar  $H_2$  + 1 bar  $H_2$ S) and gas D (120 bar  $H_2$  + 15 bar CO<sub>2</sub> + 1 bar  $H_2$ S) with an electrolyte 200 g/l NaCl rotating and one dry condition with gas A (120 bar  $H_2$ ).

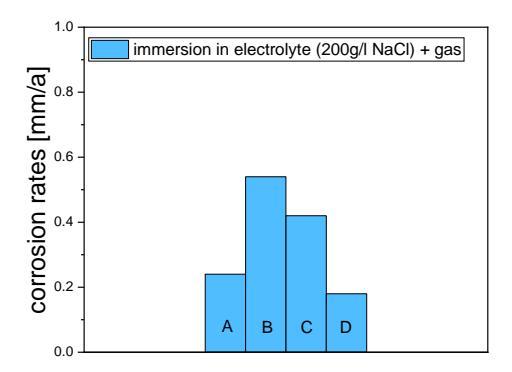
Figure 38: Hydrogen uptake of steel 20MnV5 in autoclave tests at RT in gas A (120 bar  $H_2$ ), gas B (120 bar  $H_2 + 15$  bar  $CO_2$ ), gas C (120 bar  $H_2 + 1$  bar  $H_2S$ ) and gas D (120 bar  $H_2 + 15$  bar  $CO_2 + 1$  bar  $H_2S$ ) with an electrolyte 200 g/l NaCl rotating.

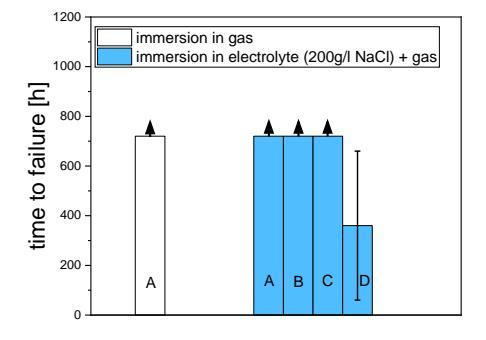
Figure 39: Time to failure of a Duplex steel 2205 consists of a ferrite and austenite microstructure at room temperature in gas A (120 bar  $H_2$ ), gas B (120 bar  $H_2$  + 15 bar CO<sub>2</sub>), gas C (120 bar  $H_2$  + 1 bar  $H_2$ S) and gas D (120 bar  $H_2$  + 15 bar CO<sub>2</sub> + 1 bar  $H_2$ S) with an electrolyte 200 g/l NaCl rotating and one dry condition with gas A (120 bar  $H_2$ ).

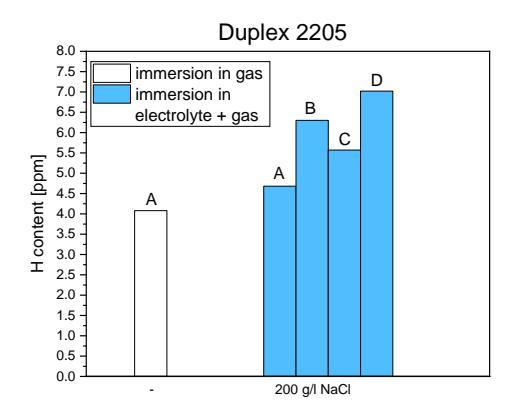
Figure 40: Hydrogen uptake of a Duplex 2205 microstructure at room temperature in gas A (120 bar  $H_2$ ), gas B (120 bar  $H_2 + 15$  bar  $CO_2$ ), gas C (120 bar  $H_2 + 1$  bar  $H_2S$ ) and gas D (120 bar  $H_2 + 15$  bar  $CO_2 + 1$  bar  $H_2S$ ) with an electrolyte 200 g/l NaCl rotating and one dry condition with gas A (120 bar  $H_2$ ).

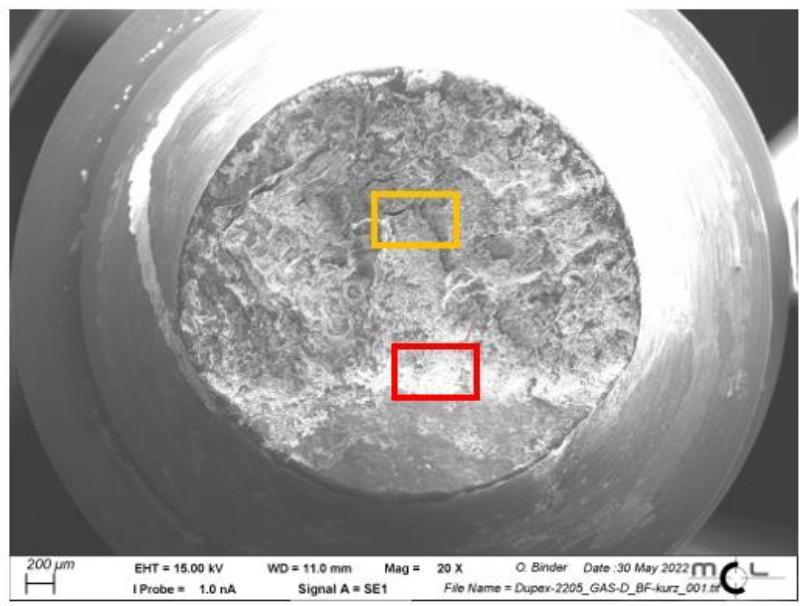
Figure 41: Fracture surface of Duplex steel 2205 austenite tested in gas D (120 bar  $H_2$  + 15 bar  $CO_2$  + 1 bar  $H_2S$ ), 200 g/l NaCl, room temperature, 20x.

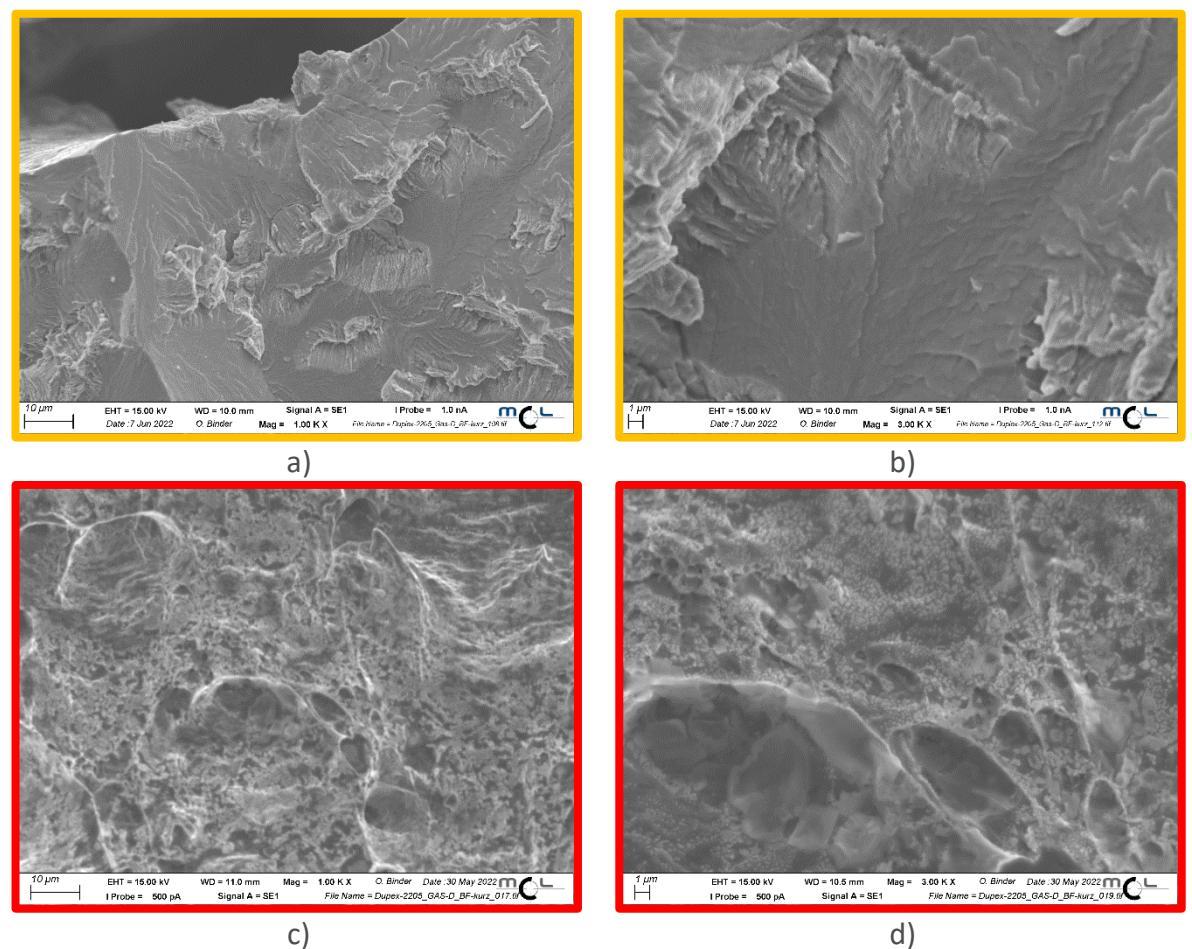
Figure 42: Details of fracture surface of Duplex 2205 in a) and b) brittle fracture area, c) and d) shows the ductile fractured area.

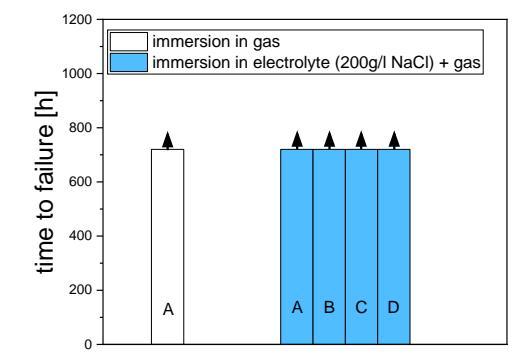
Figure 43: Time to failure of a welded Alloy 625 with a dendritic microstructure at room temperature in gas A (120 bar  $H_2$ ), gas B (120 bar  $H_2$  + 15 bar CO<sub>2</sub>), gas C (120 bar  $H_2$  + 1 bar  $H_2$ S) and gas D (120 bar  $H_2$  + 15 bar CO<sub>2</sub> + 1 bar  $H_2$ S) with an electrolyte 200 g/l NaCl rotating and one dry condition with gas A (120 bar  $H_2$ ).

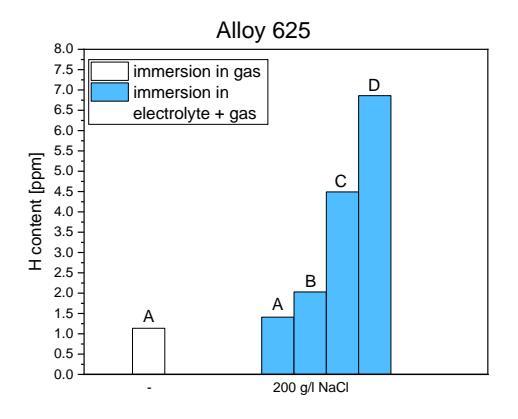
Figure 44: Hydrogen uptake of a welded Alloy 625 with a dendritic microstructure at room temperature in gas A (120 bar  $H_2$ ), gas B (120 bar  $H_2$  + 15 bar  $CO_2$ ), gas C (120 bar  $H_2$  + 1 bar  $H_2$ S) and gas D (120 bar  $H_2$  + 15 bar  $CO_2$  + 1 bar  $H_2$ S) with an electrolyte 200 g/l NaCl rotating and one dry condition with gas A (120 bar  $H_2$ ).

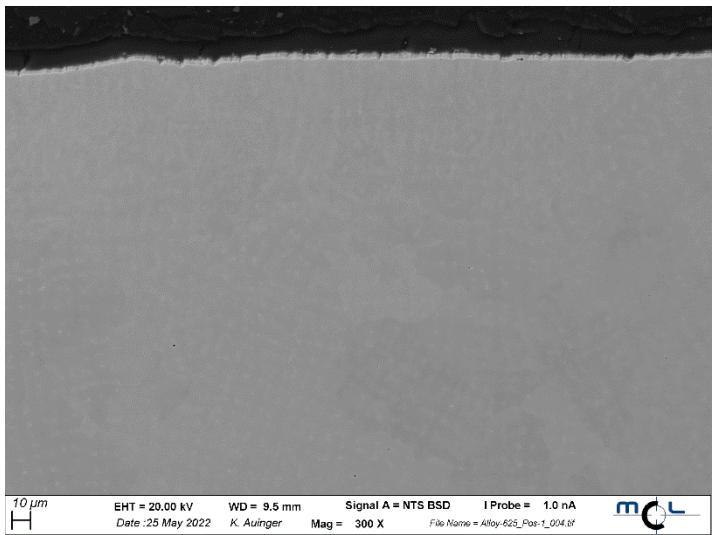
Figure 45: Cross-section of Alloy 625 at magnification 300x, with Gas D containing 200g/l NaCl at RT.

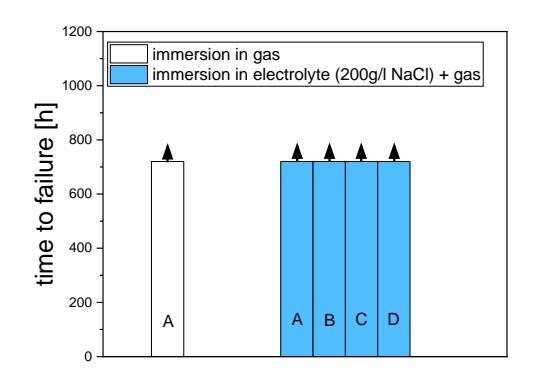
Figure 46: Time to failure of a stainless steel 316L from supplier 1 at room temperature in gas A (120 bar  $H_2$ ), gas B (120 bar  $H_2 + 15$  bar  $CO_2$ ), gas C (120 bar  $H_2 + 1$  bar  $H_2S$ ) and gas D (120 bar  $H_2 + 15$  bar  $CO_2 + 1$  bar  $H_2S$ ) with an electrolyte 200 g/l NaCl rotating and one dry condition with gas A (120 bar  $H_2$ ).

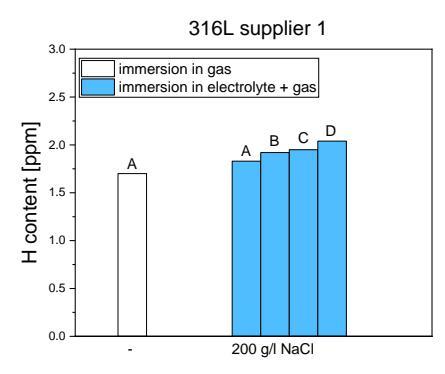
Figure 47: Hydrogen uptake of a stainless steel 316L from supplier 1 at room temperature in gas A (120 bar  $H_2$ ), gas B (120 bar  $H_2$  + 15 bar  $CO_2$ ), gas C (120 bar  $H_2$  + 1 bar  $H_2S$ ) and gas D (120 bar  $H_2$  + 15 bar  $CO_2$  + 1 bar  $H_2S$ ) with an electrolyte 200 g/l NaCl rotating and one dry condition with gas A (120 bar  $H_2$ ).

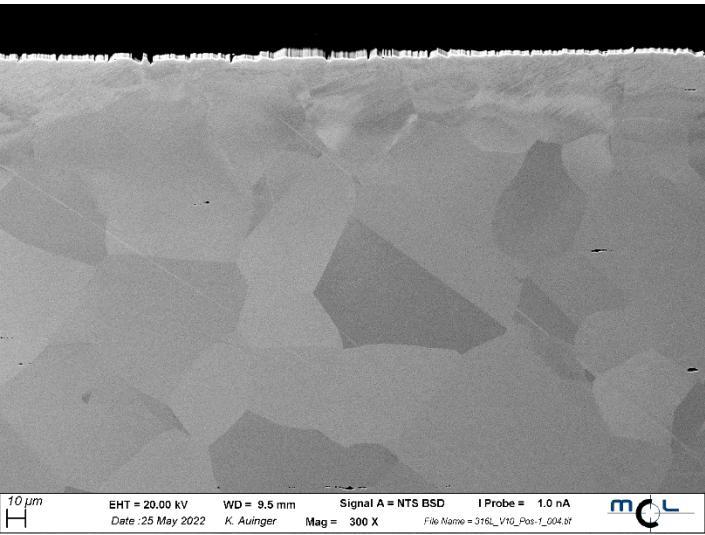
Figure 48: Cross-section of a stainless steel 316 L (supplier 1) at magnification 300x, with gas D containing 200g/l NaCl at RT.

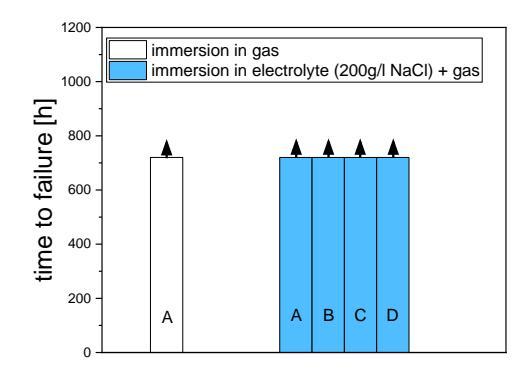
Figure 49: Time to failure of a stainless steel 316L from supplier 2 at room temperature in gas A (120 bar  $H_2$ ), gas B (120 bar  $H_2 + 15$  bar  $CO_2$ ), gas C (120 bar  $H_2 + 1$  bar  $H_2S$ ) and gas D (120 bar  $H_2 + 15$  bar  $CO_2 + 1$  bar  $H_2S$ ) with an electrolyte 200 g/l NaCl rotating and one dry condition with gas A (120 bar  $H_2$ ).

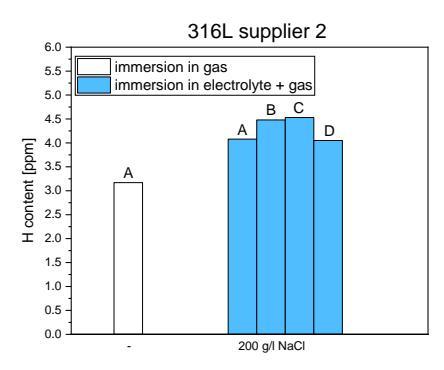
Figure 50: Hydrogen uptake of a stainless steel 316L (supplier 2) at room temperature in gas A (120 bar  $H_2$ ), gas B (120 bar  $H_2 + 15$  bar  $CO_2$ ), gas C (120 bar  $H_2 + 1$  bar  $H_2S$ ) and gas D (120 bar  $H_2 + 15$  bar  $CO_2 + 1$  bar  $H_2S$ ) with an electrolyte 200 g/l NaCl rotating and one dry conditions with gas A (120 bar  $H_2$ ).

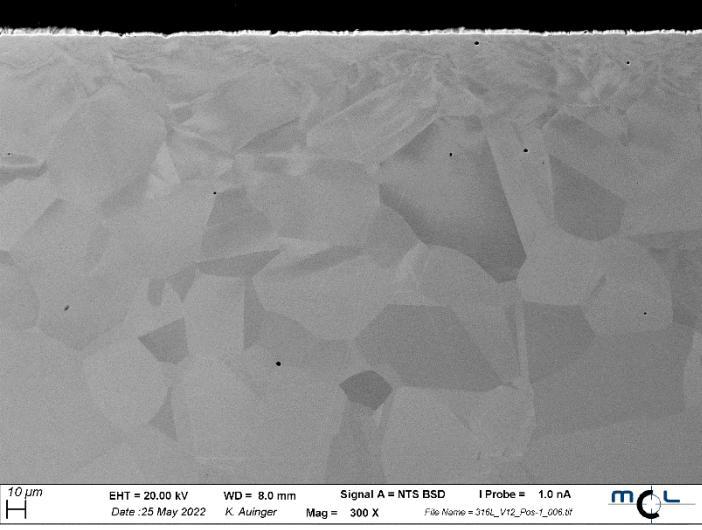
Figure 51: Cross-section of a stainless steel 316L (supplier 2) at magnification 300x, with Gas D containing 200g/l NaCl at RT.

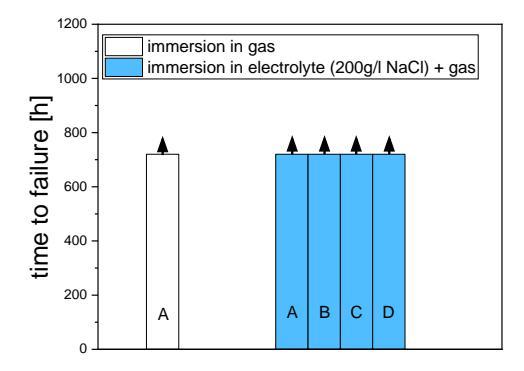
Figure 52: Time to failure of a tempered martensite 13% Cr-steel at room temperature in gas A (120 bar  $H_2$ ), gas B (120 bar  $H_2$  + 15 bar  $CO_2$ ), gas C (120 bar  $H_2$  + 1 bar  $H_2$ S) and gas D (120 bar  $H_2$  + 15 bar  $CO_2$  + 1 bar  $H_2$ S) with an electrolyte 200 g/l NaCl rotating and one dry condition with gas A (120 bar  $H_2$ ).

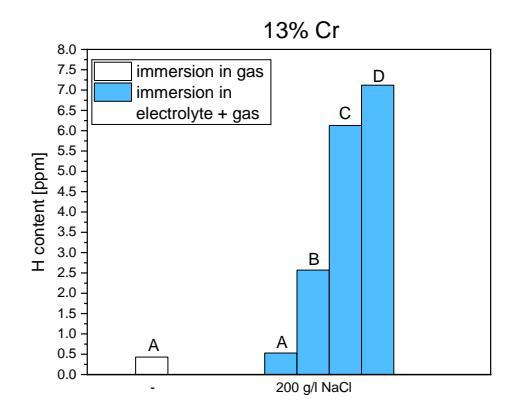
Figure 53: Hydrogen uptake of a tempered martensite 13% Cr-steel at room temperature in gas A (120 bar  $H_2$ ), gas B (120 bar  $H_2$  + 15 bar CO<sub>2</sub>), gas C (120 bar  $H_2$  + 1 bar  $H_2$ S) and gas D (120 bar  $H_2$  + 15 bar CO<sub>2</sub> + 1 bar  $H_2$ S) with an electrolyte 200 g/l NaCl rotating and one dry condition with gas A (120 bar  $H_2$ ).

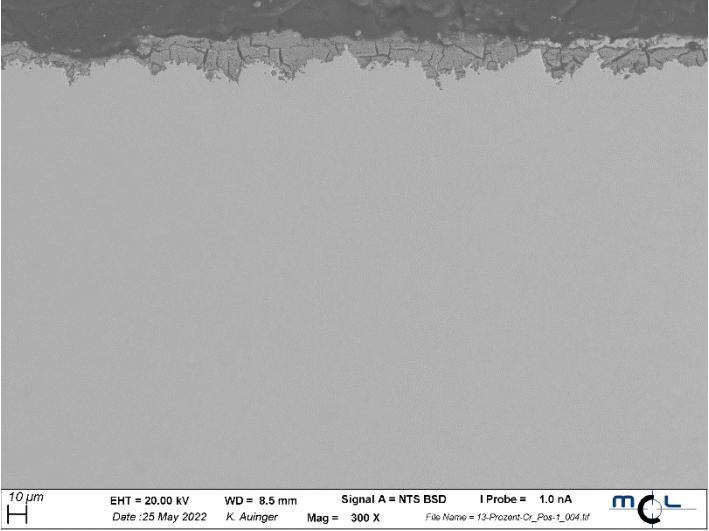
Figure 54: Cross-section of a tempered martensite 13% Cr-steel at magnification 300x, with Gas D containing 200g/l NaCl at RT.

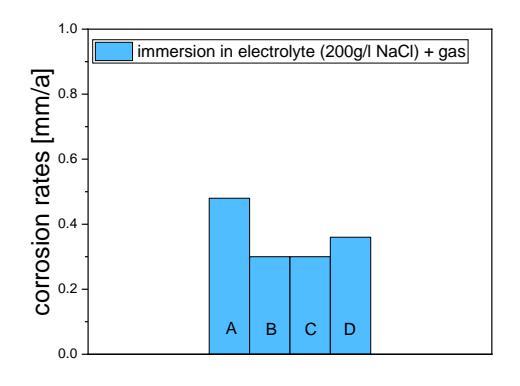
Figure 55: Hydrogen uptake of a tempered martensite 13% Cr-steel in autoclave tests at RT in gas A (120 bar H2), gas B (120 bar  $H_2$  + 15 bar  $CO_2$ ), gas C (120 bar  $H_2$  + 1 bar  $H_2$ S) and gas D (120 bar  $H_2$  + 15 bar  $CO_2$  + 1 bar  $H_2$ S) with an electrolyte 200 g/l NaCl rotating.

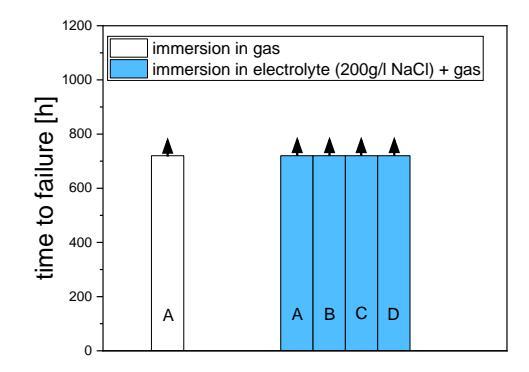
Figure 56: Time to failure of a ferritic perlitic pre-corroded steel K55 at room temperature in gas A (120 bar  $H_2$ ), gas B (120 bar  $H_2 + 15$  bar  $CO_2$ ), gas C (120 bar  $H_2 + 1$  bar  $H_2$ S) and gas D (120 bar  $H_2 + 15$  bar  $CO_2 + 1$  bar  $H_2$ S) with an electrolyte 200 g/l NaCl rotating and one dry condition with gas A (120 bar  $H_2$ ).

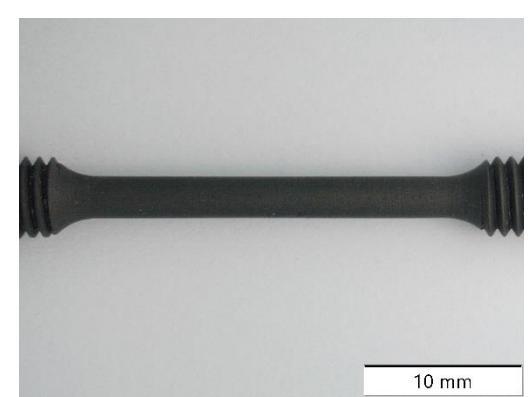
Figure 57: Pre-corroded sample after one week in a autoclave with 200 g/l NaCl at room temperature with 15 bar CO<sub>2</sub>.

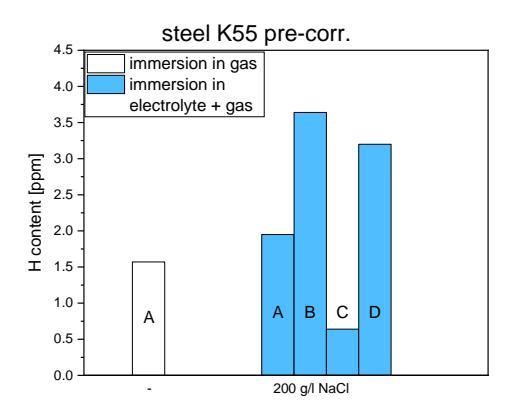
Figure 58: Hydrogen uptake of a ferritic perlitic pre-corroded steel K55 at room temperature in gas A (120 bar  $H_2$ ), gas B (120 bar  $H_2 + 15$  bar  $CO_2$ ), gas C (120 bar  $H_2 + 1$  bar  $H_2S$ ) and gas D (120 bar  $H_2 + 15$  bar  $CO_2 + 1$  bar  $H_2S$ ) with an electrolyte 200 g/l NaCl rotating and one dry condition with gas A (120 bar  $H_2$ ).

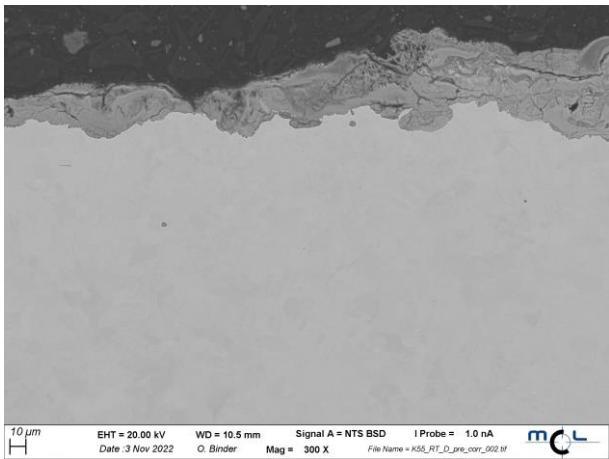
Figure 59: Cross-section of steel K55 pre-corroded at magnification 300x, with Gas D containing 200g/l NaCl at RT.

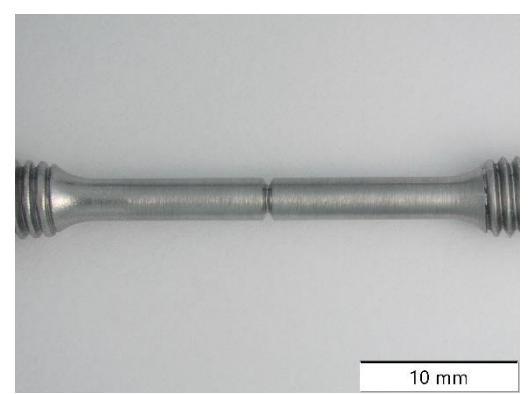
Figure 62: Sample with a v-Notch with a 0.5 mm indentation.
